THE CITY OF CHILLICOTHE, MISSOURI  
POLICE DEPARTMENT HEADQUARTERS

# **FACILITY ASSESSMENT**

613 WALNUT ST. CHILLICOTHE, MO 64601

**DATE COMPLETED:** April 8, 2024

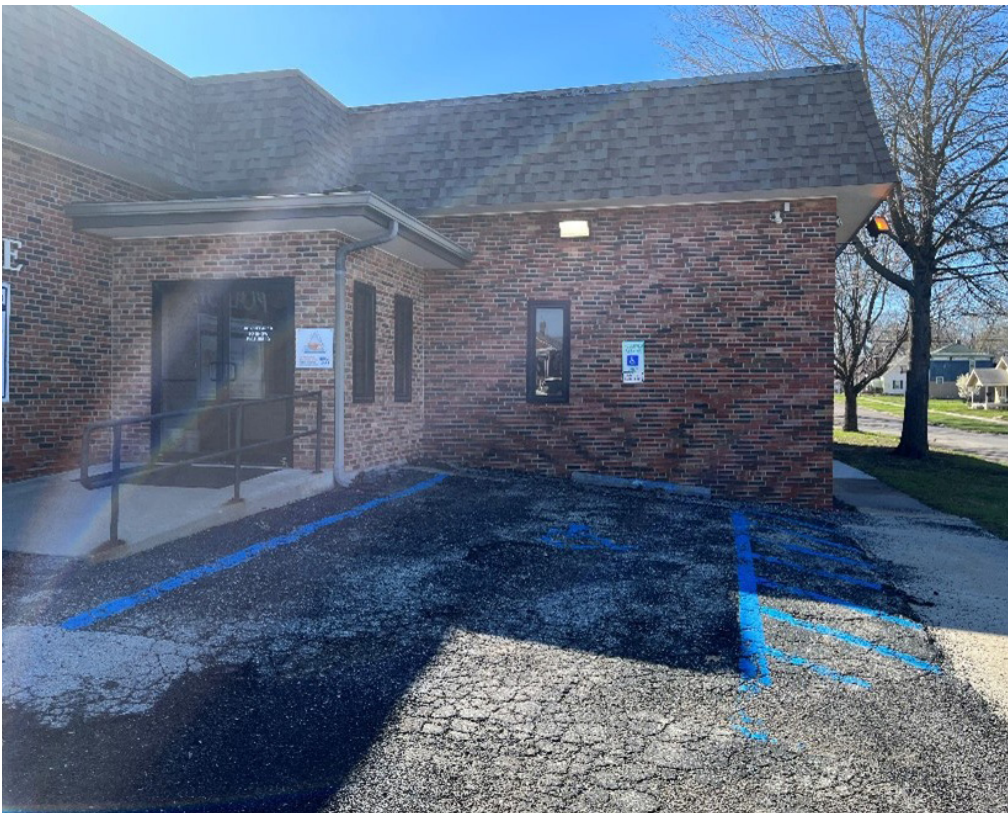
The ADA parking stall and ramp at the North entrance of the Police Department are not in compliance with ADA code. The existing cross slope is 4.20%, which exceeds the maximum of 2.08% in any one direction.

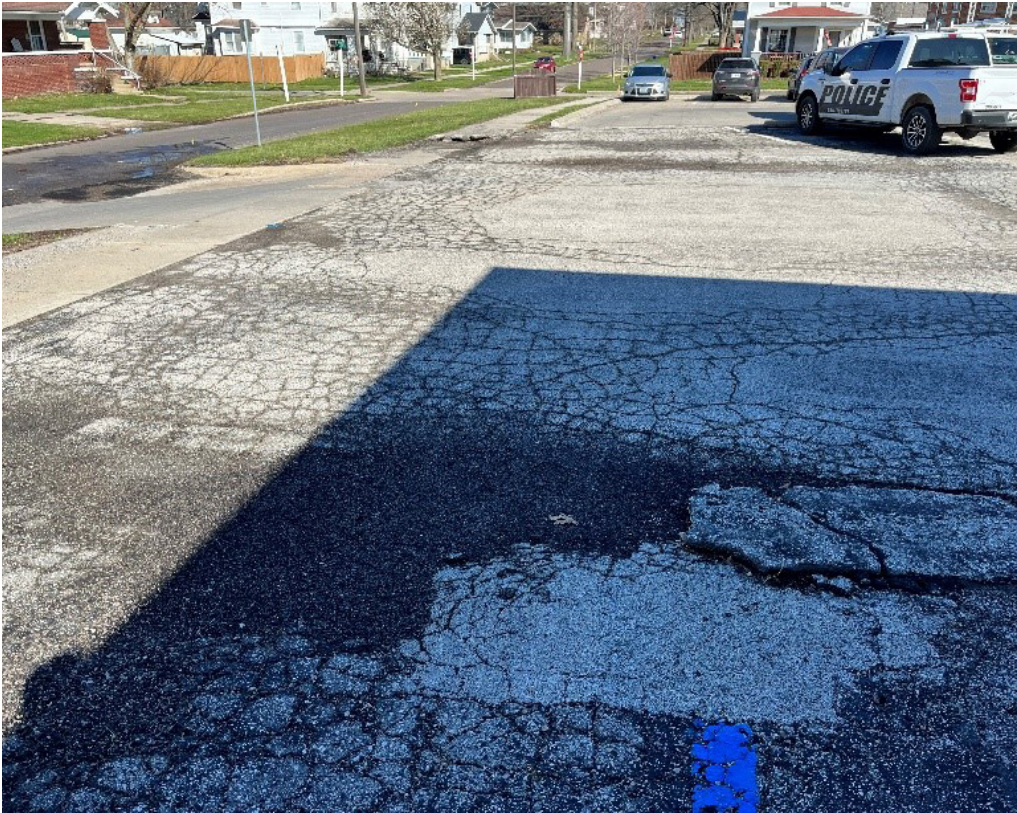
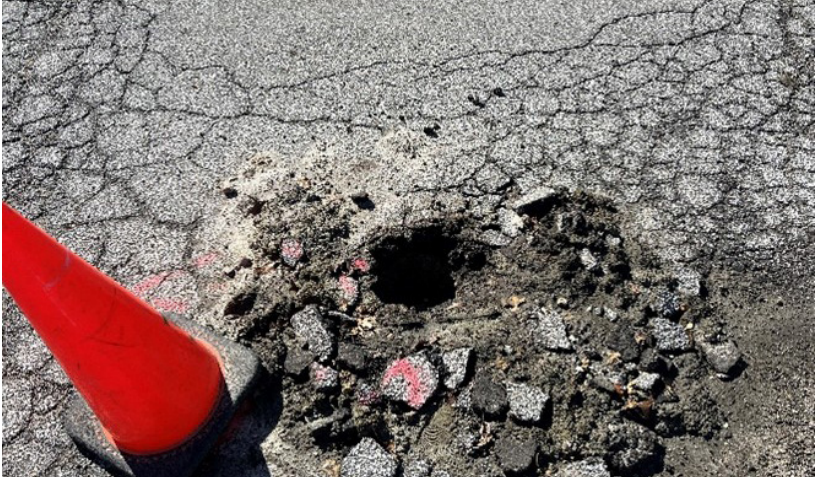
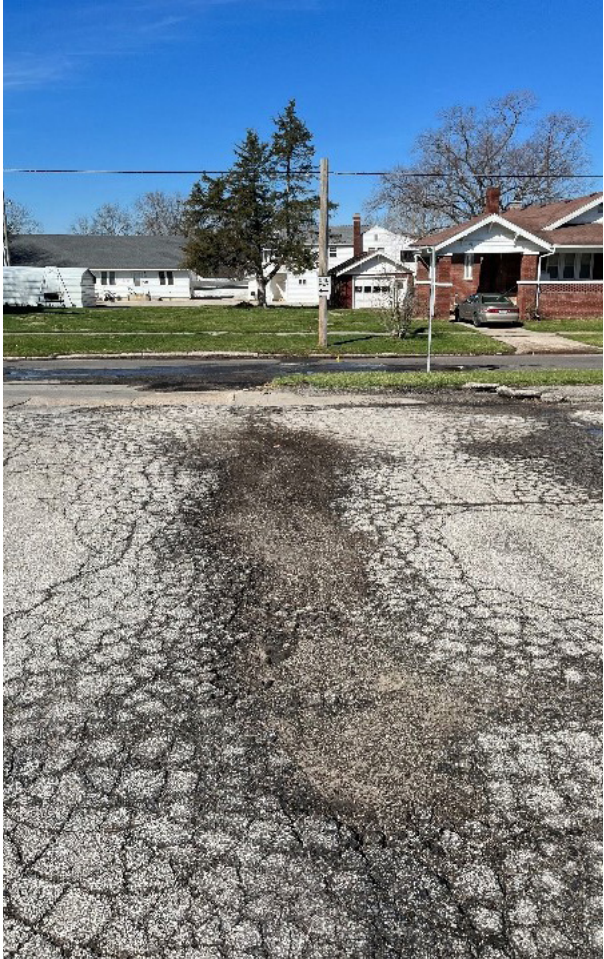
Existing asphalt pavement on all portions of the Police Department parking lot and general site is in poor condition. The parking lot has multiple areas where the surface asphalt has been chipped, rutted, and cracked. Existing curbs have also been cracked and destroyed. Many of these areas have become localized low points where water accumulates as evidenced by sediment deposits. BHC's site visit occurred a few days after a period of rain and these areas were still damp or had evidence of previous standing water.

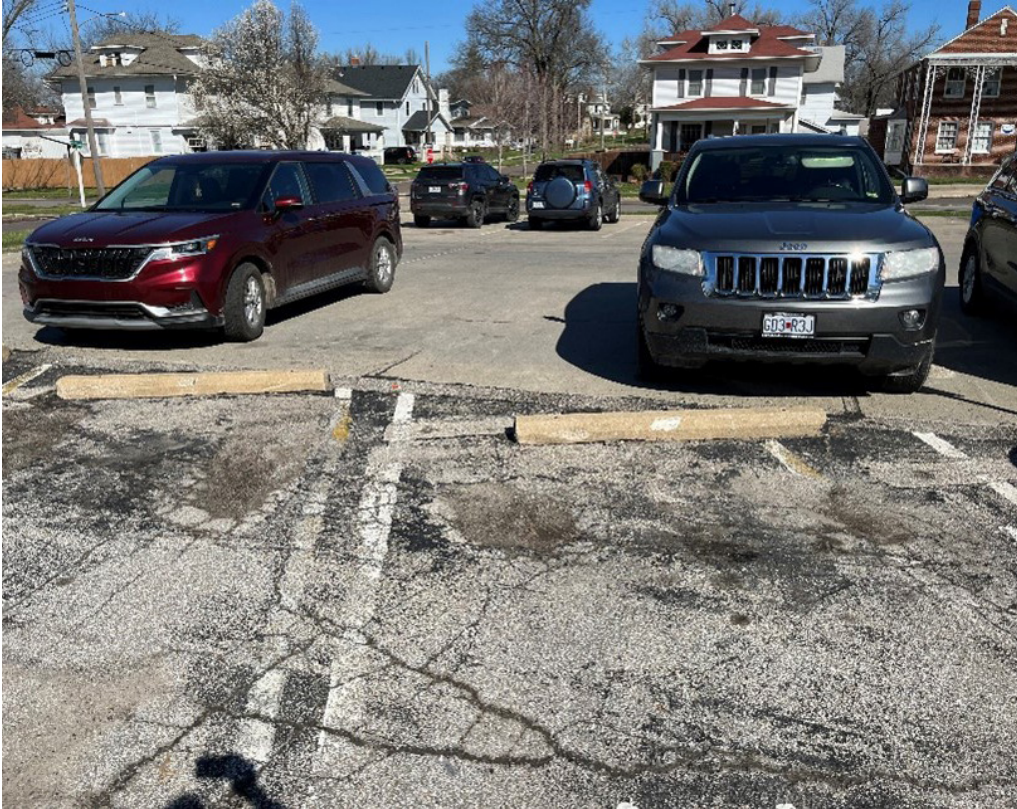
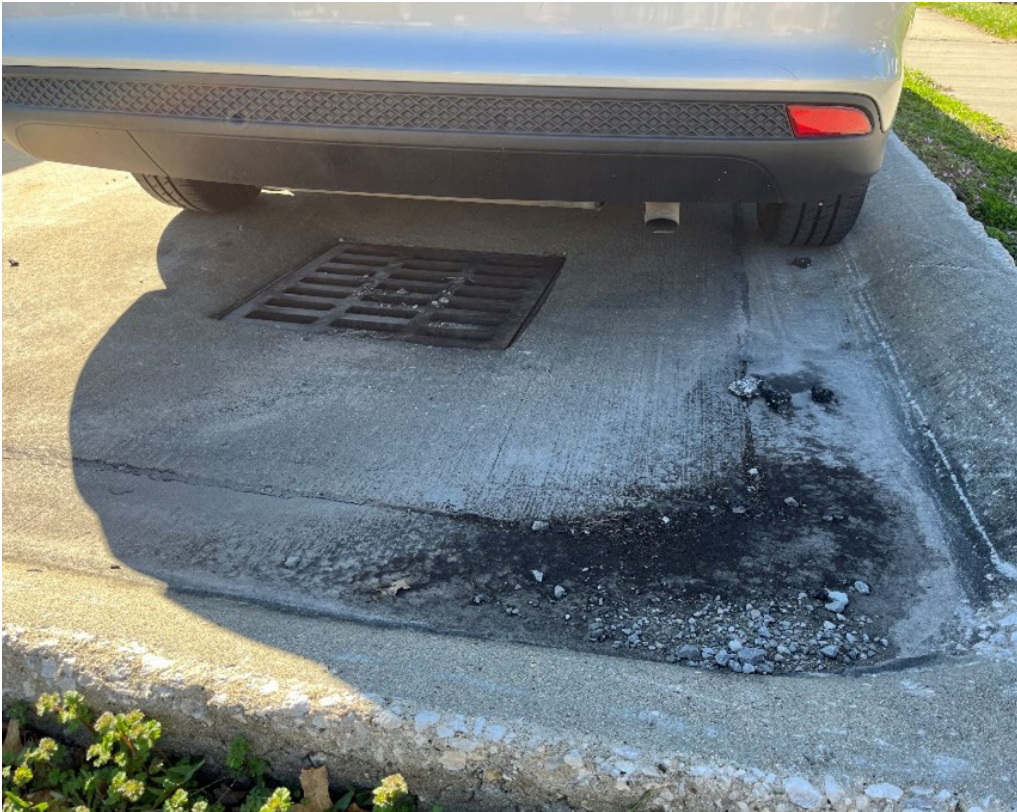
The existing concrete parking lot at the far North portion of the site appears to be in acceptable condition. However, the area inlet in the Northwest corner of this parking lot appears to allow standing water as evidenced by sediment deposits.

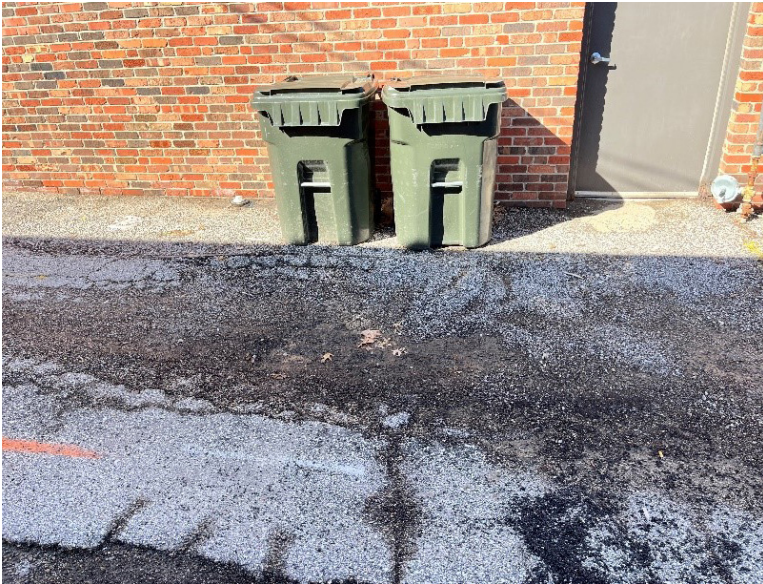
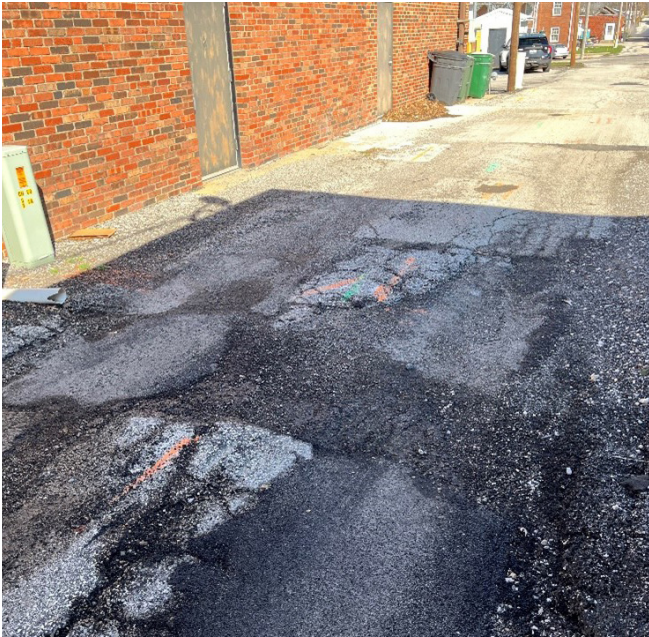
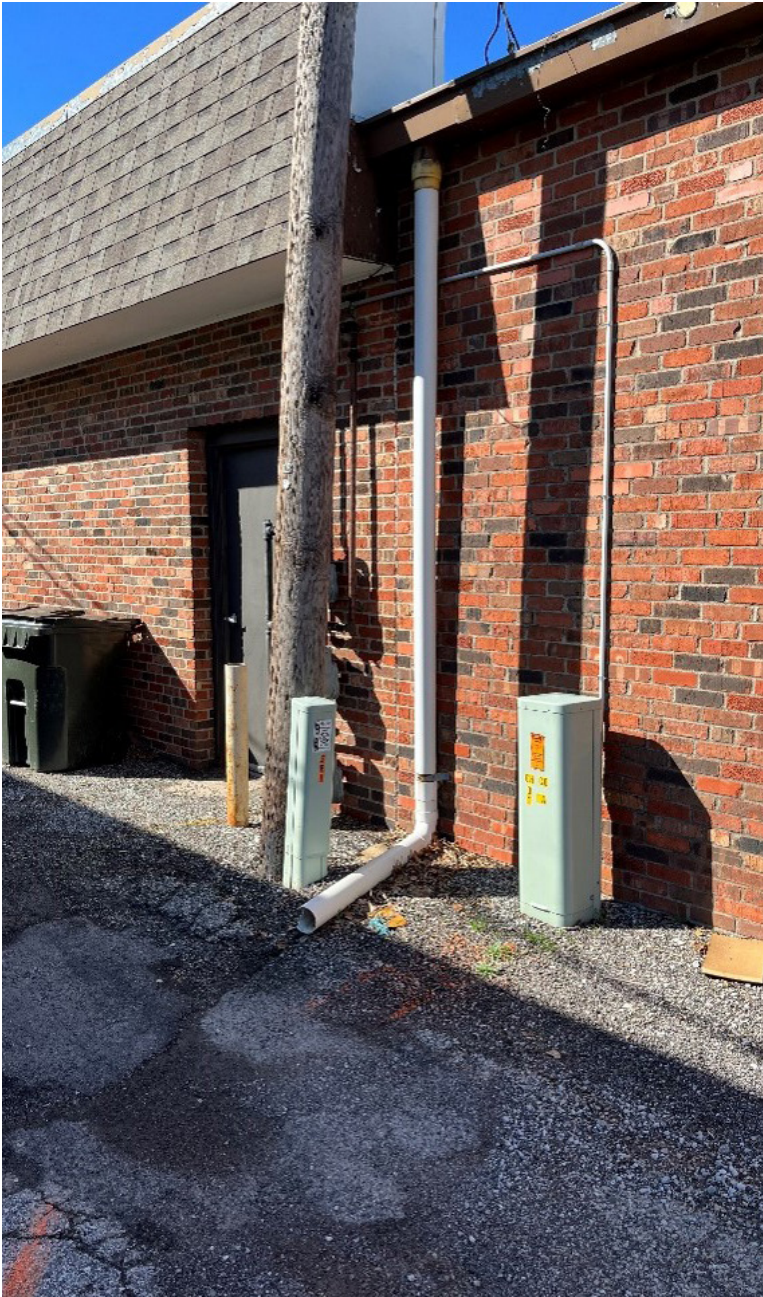
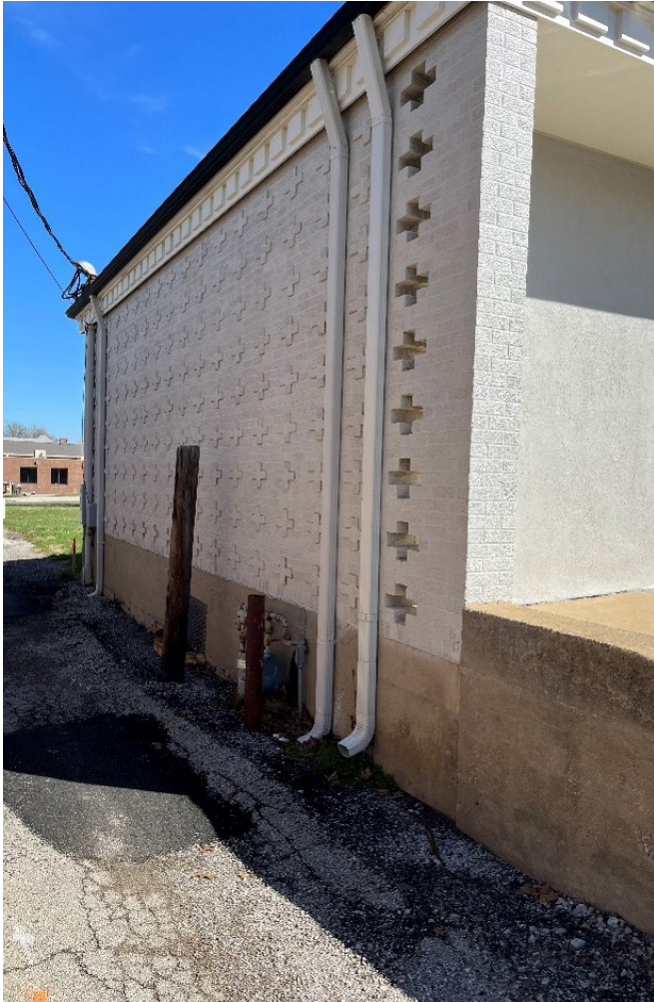
The paved alley that bisects the Police Department site is in poor condition and has multiple areas of partially destroyed asphalt pavement. Roof drains from the Police Department and exiting building to the East discharge into this alley. In some areas, this discharge point is rutted out and appears to be a local low point where water stands.

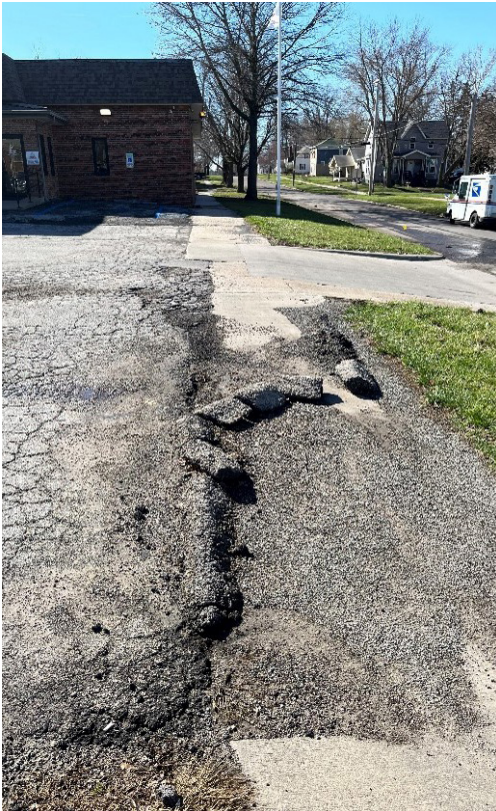
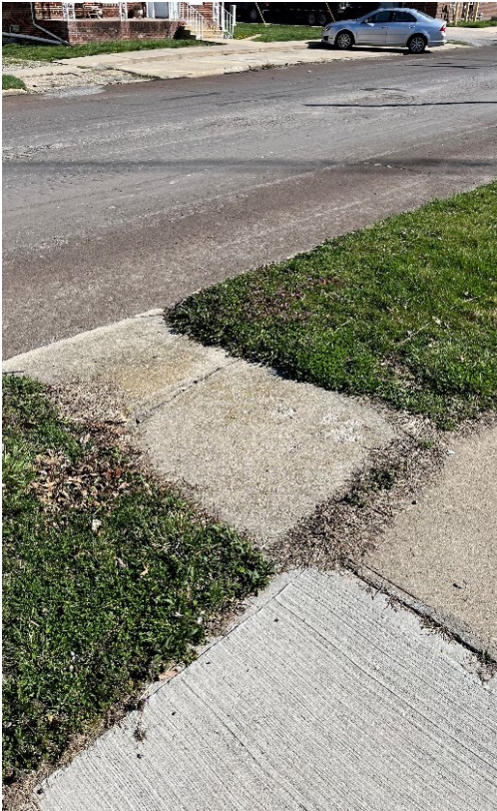
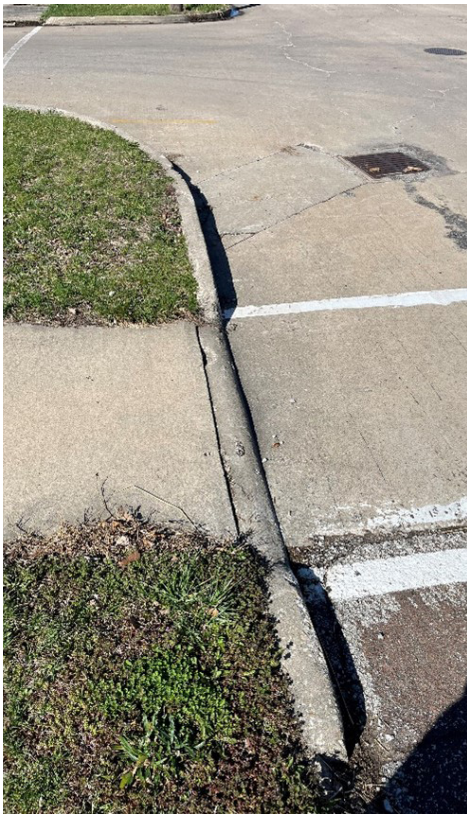
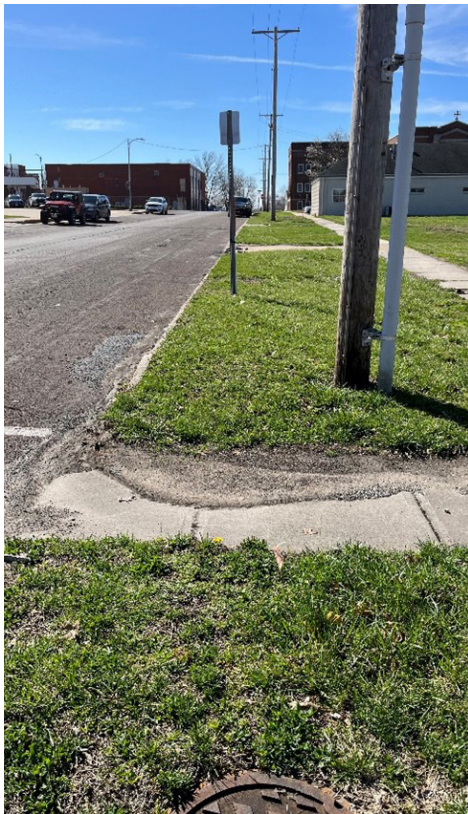
The existing sidewalks surrounding the Police Department property are in a mixed state, varying from poor to acceptable conditions. There is a portion of the sidewalk on the West property line that has destroyed curb blocking the walkway with what appears to be base course covering it. Many of the sidewalk ramps to the public street and crosswalks do not meet ADA standards for a ramp as the sidewalk ends at a full height curb. Many of the sidewalks have areas that appear to have standing water as evidenced by sediment deposits.

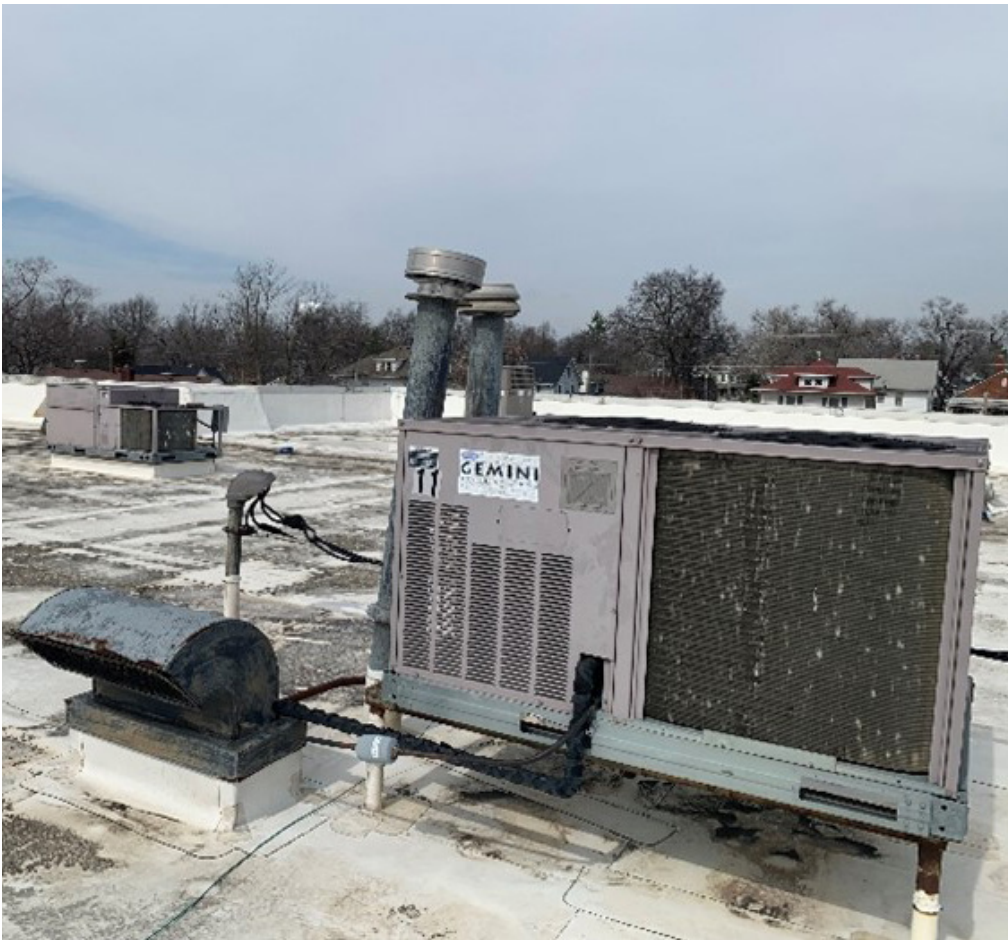
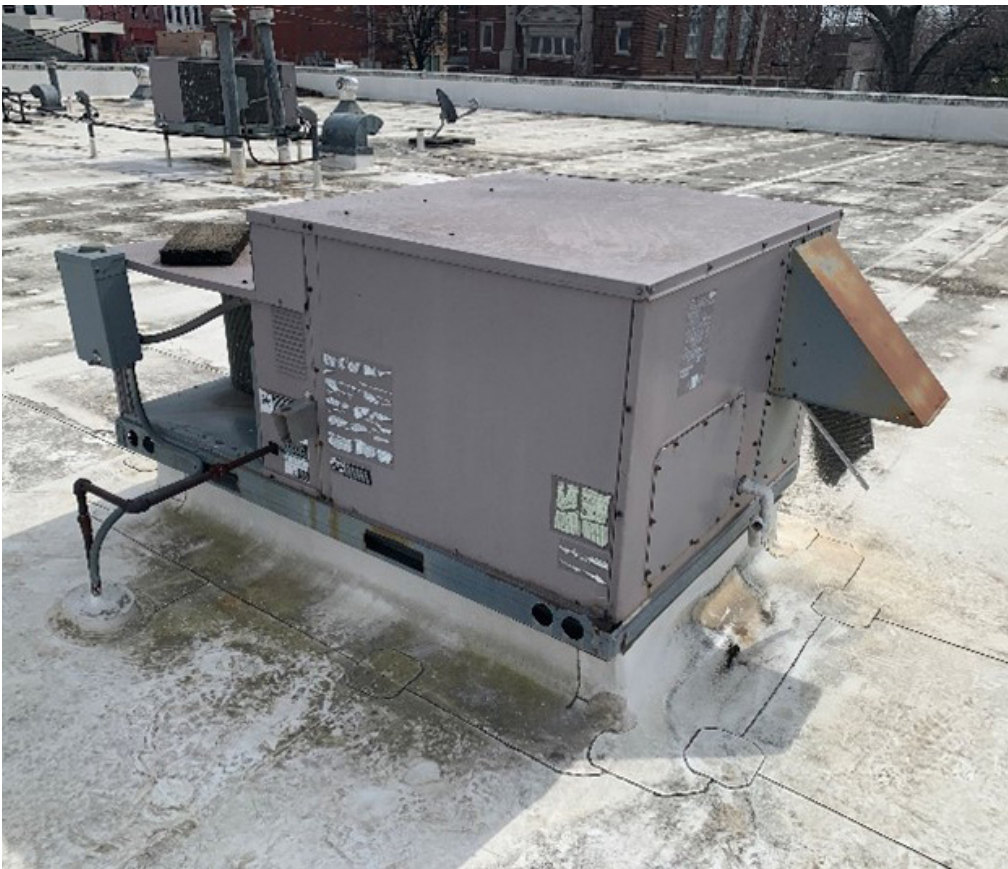
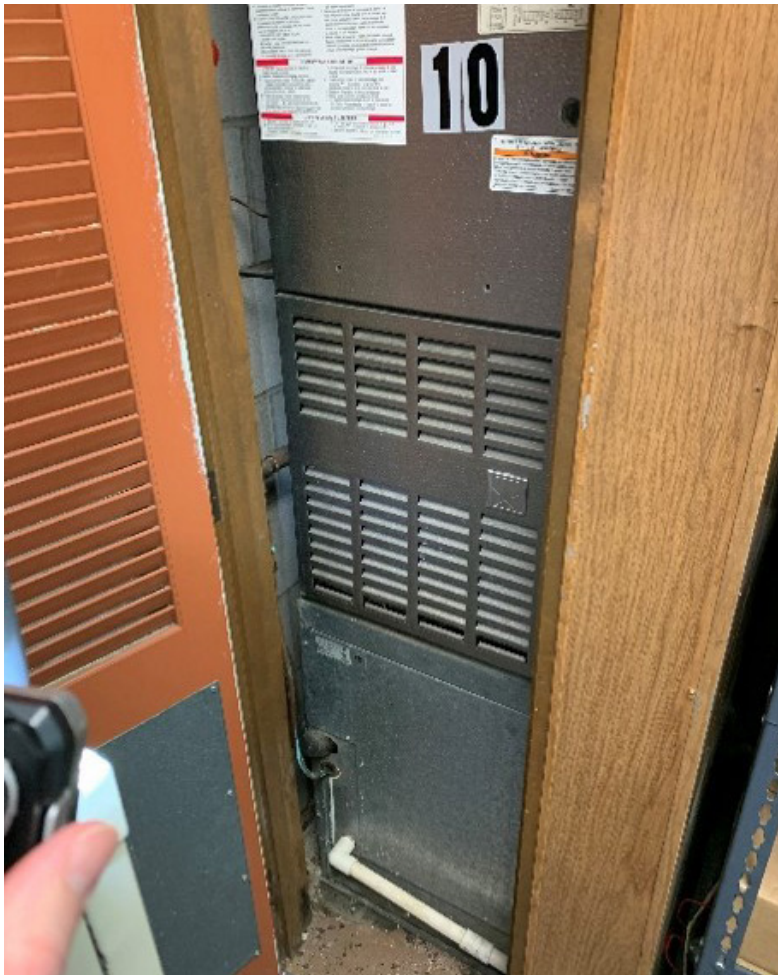
The majority of the HVAC equipment serving both sides of the building is at or beyond its expected useful life. The building is heated and cooled by several split systems with condensers on the roof and 2 rooftop units. Few units have outside air, and none meet the currently adopted building codes for ventilation. Boiler flues are too close to outside air intakes, which can allow flue gases to enter the building ventilation. RTUs and Condensing units on the roof are rusting. Several units contain R22, a refrigerant which is no longer manufactured due to EPA regulations. Some split systems are in closets too small to allow service or replacement, and walls would need to be demolished to replace them.

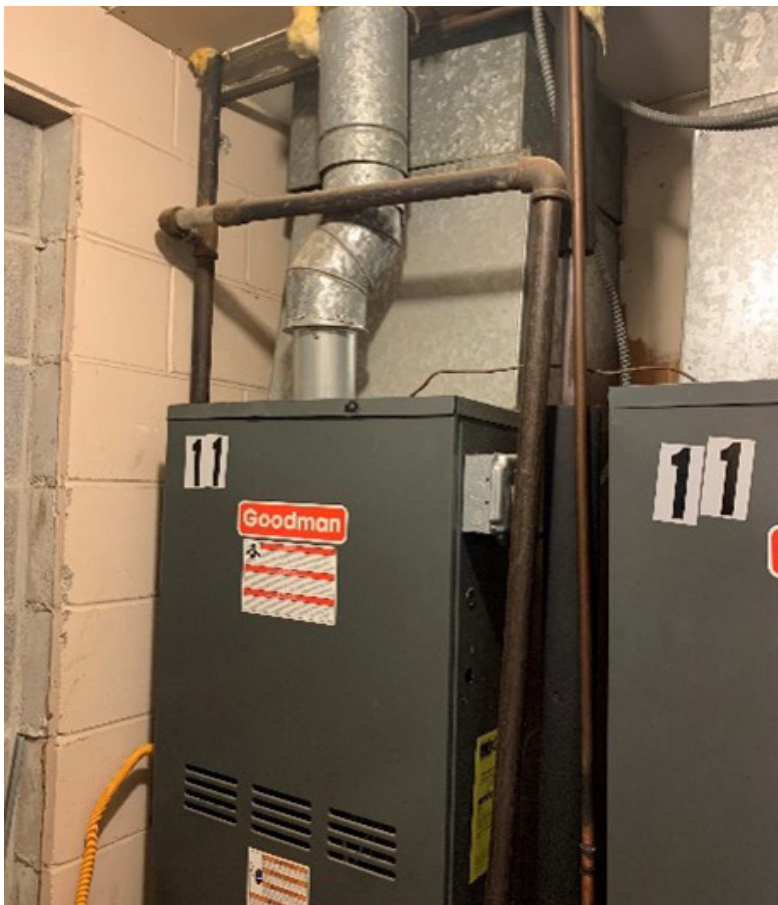
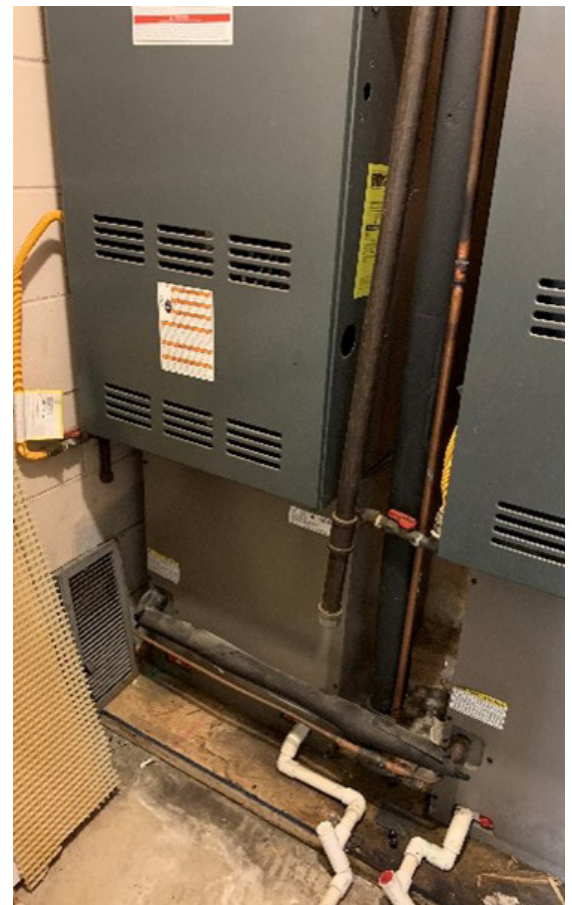
HVAC zoning is inadequate and not up to the currently adopted building codes. Exterior rooms are zoned with interior rooms creating hot and cold swings. Total HVAC capacity is inadequate, leading to uncomfortably hot spaces and high humidity. 2/3rds of the exhaust fans within the building no longer operate, creating humidity and odor issues. There is no exhaust in the property storage areas. Most diffusers are covered in dust.

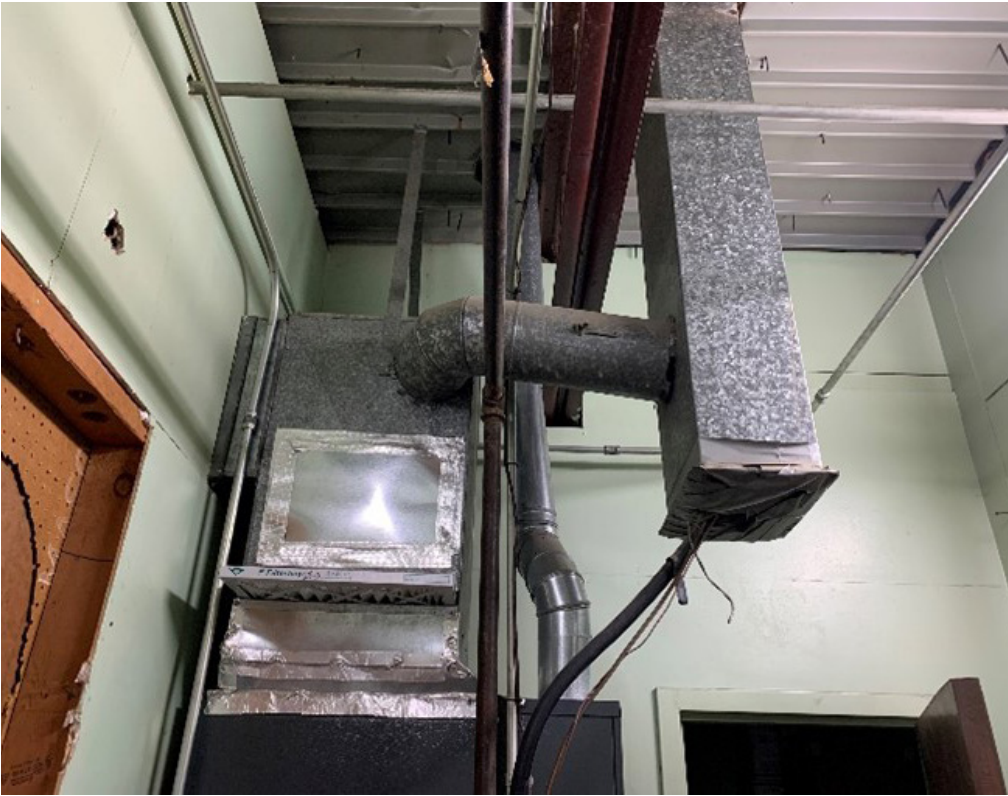
Most ductwork does not have insulation. Transfer grilles create holes in walls reducing sound privacy to zero. The ceiling is insulated with unfaced Batt insulation that lays on top of the ceiling tiles. This insulation is not tight, and allows significant infiltration from ceiling plenum. This ceiling return plenum is uninsulated.

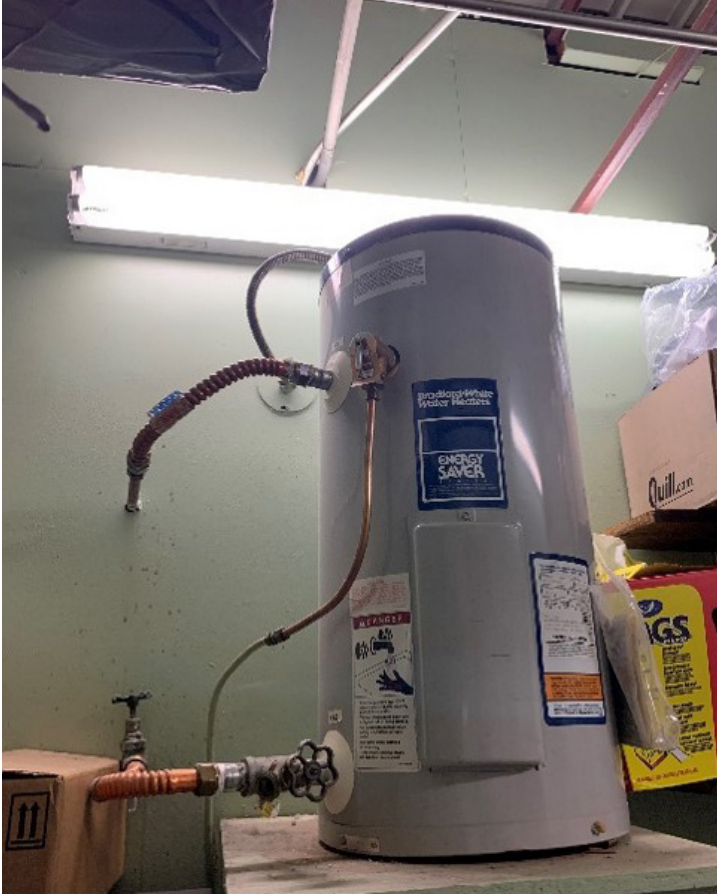
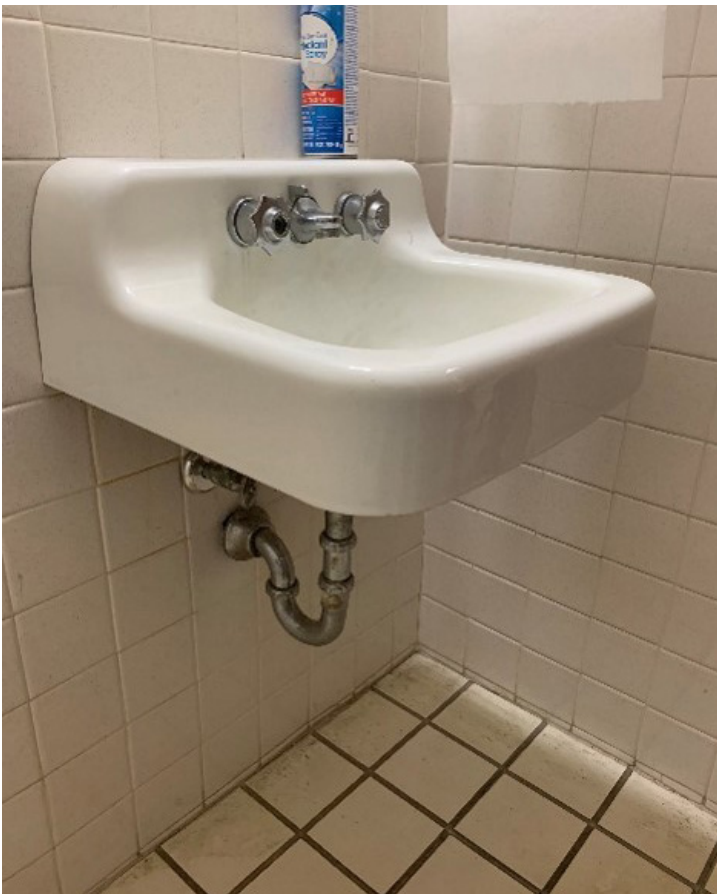
Water heaters are 5-8 years old. General window of replacement is 15 years. Most water heaters do not have drain pans below them. Most other plumbing fixtures such as sinks, toilets, and showers are beyond their expected useful life.

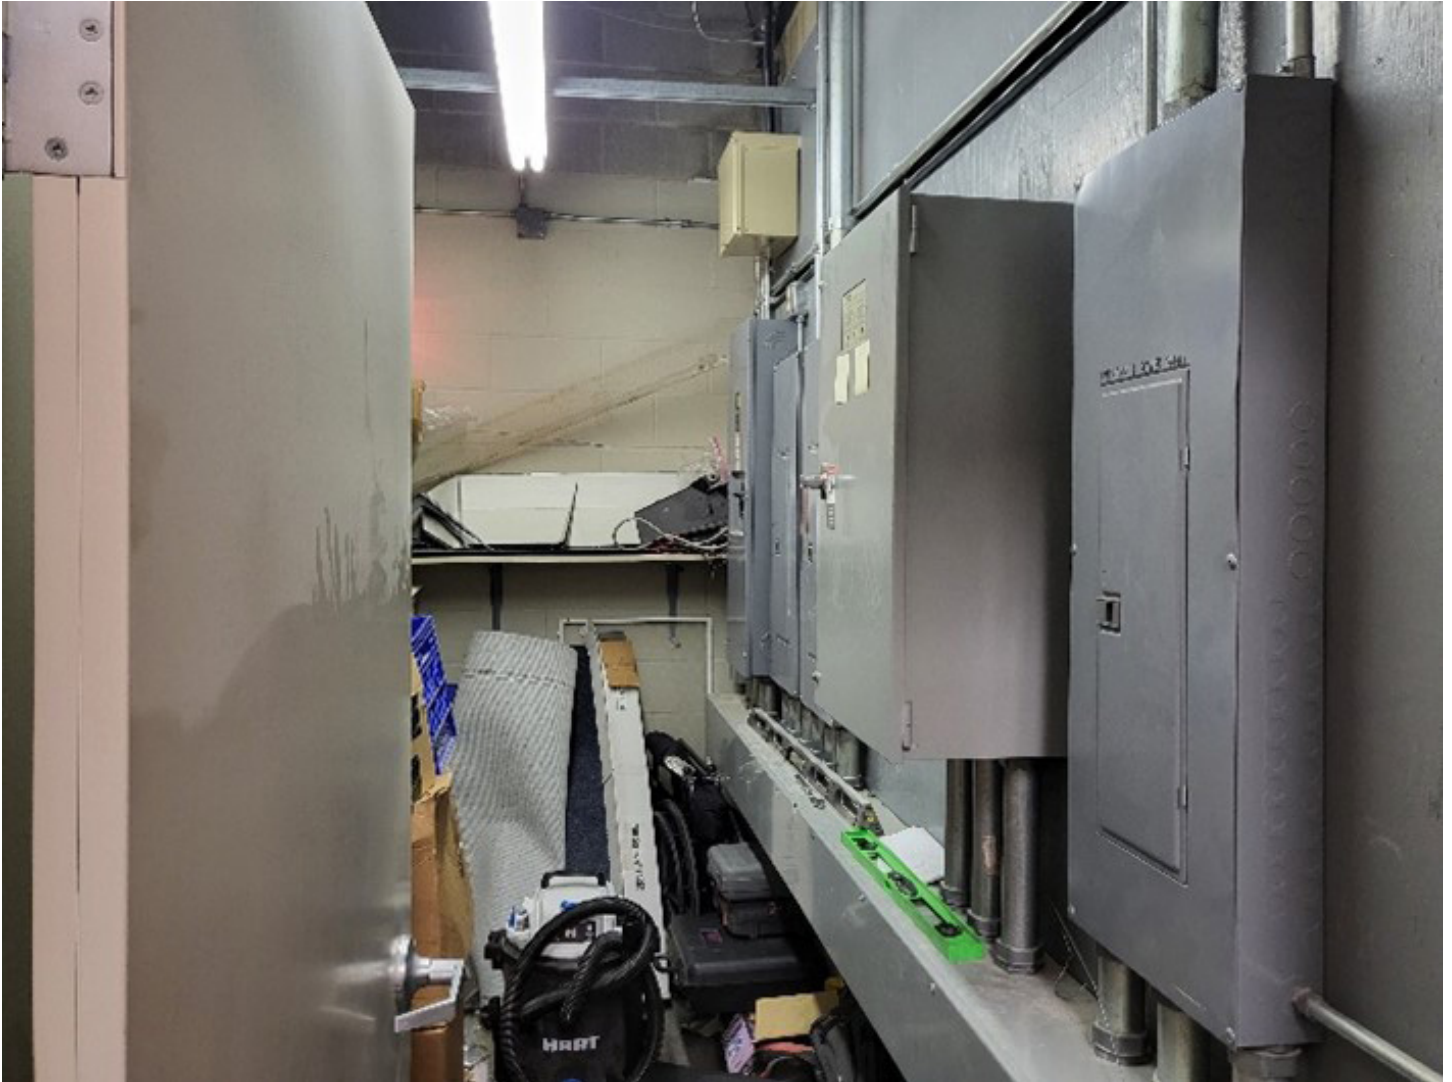
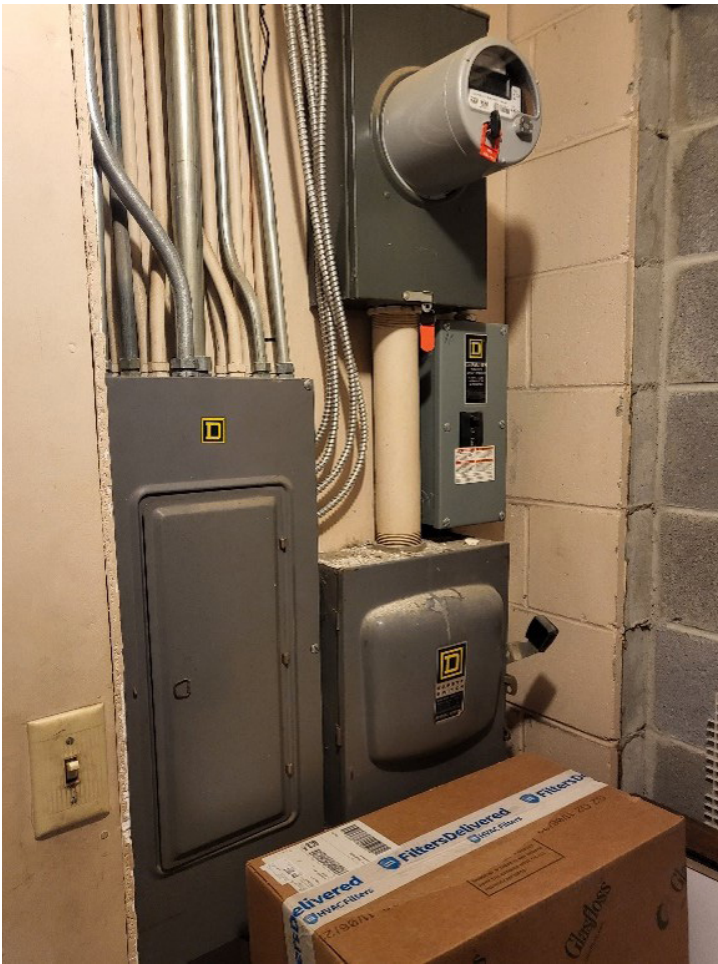
On the police side of the building, the electrical system is in surprisingly good condition given its age; however, the equipment is nearing the end of its useful life, and it is recommended it be replaced before it begins malfunctioning. Clearances for the panels are being violated by stored boxes, vacuums, and equipment, and there are no obvious alternate locations for everything being stored in the space.

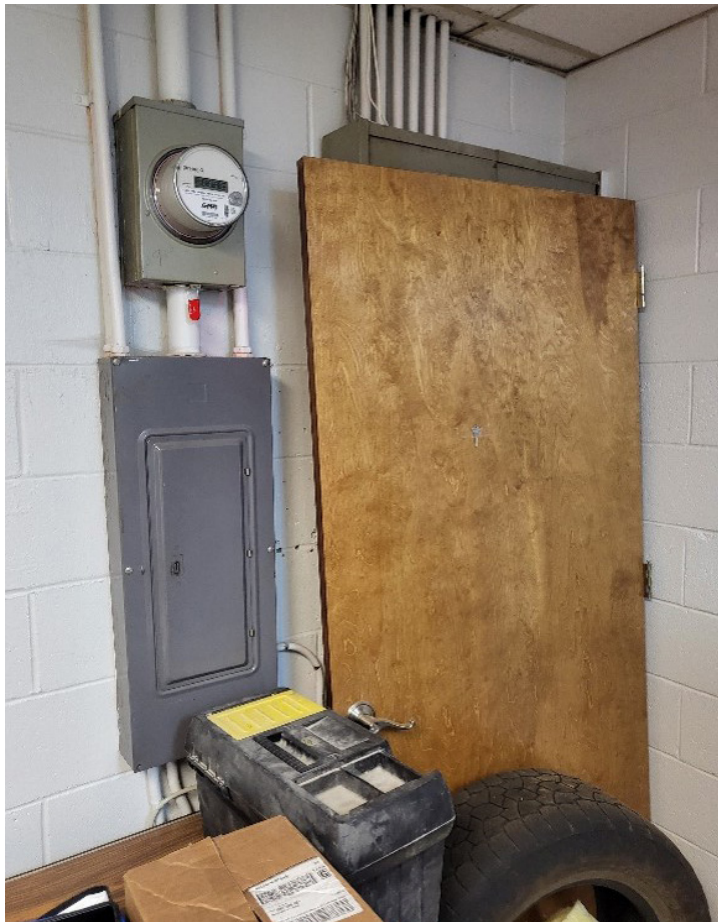
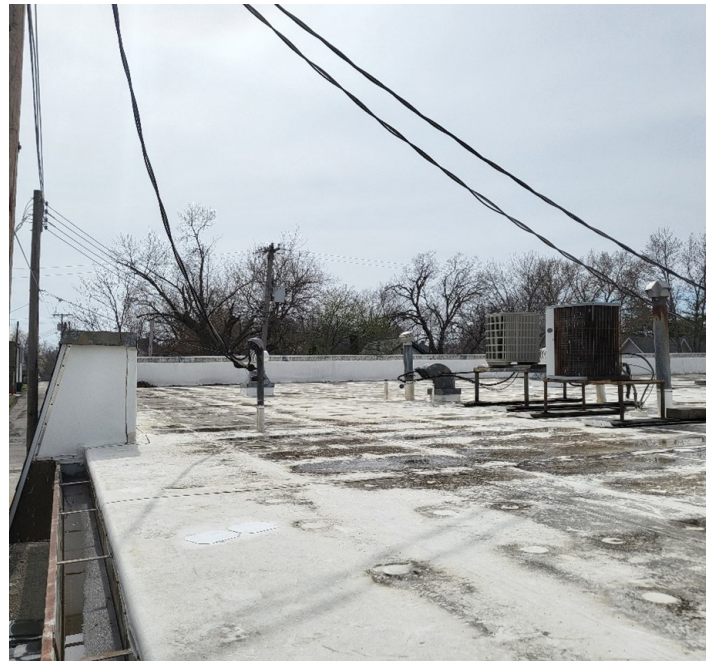
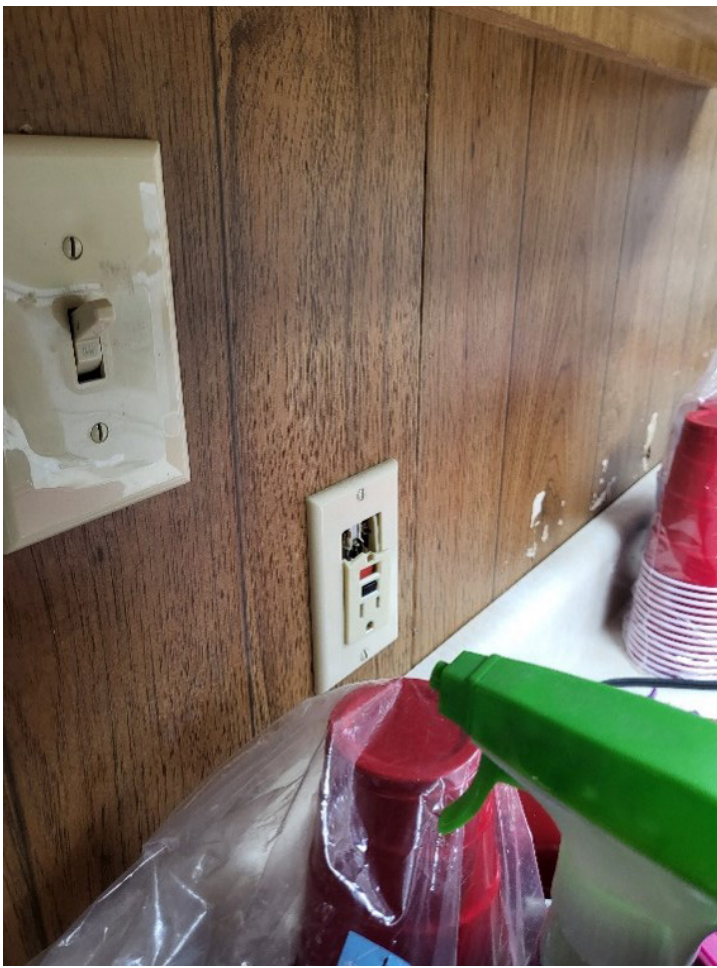
On the sheriff side of the building, the electrical system is past its useful life and needs to be replaced in its entirety. The service conductors above the roof are a code violation (NEC 230.24) and fire hazard. Meters are located inside the building, which makes gathering information difficult for the utility provider. Panel clearances are violated by numerous items, including items that are heavy and/or difficult to move if someone needed to access the panel quickly. It is recommended this portion of the building be brought up to code as soon as possible for everyone's safety.

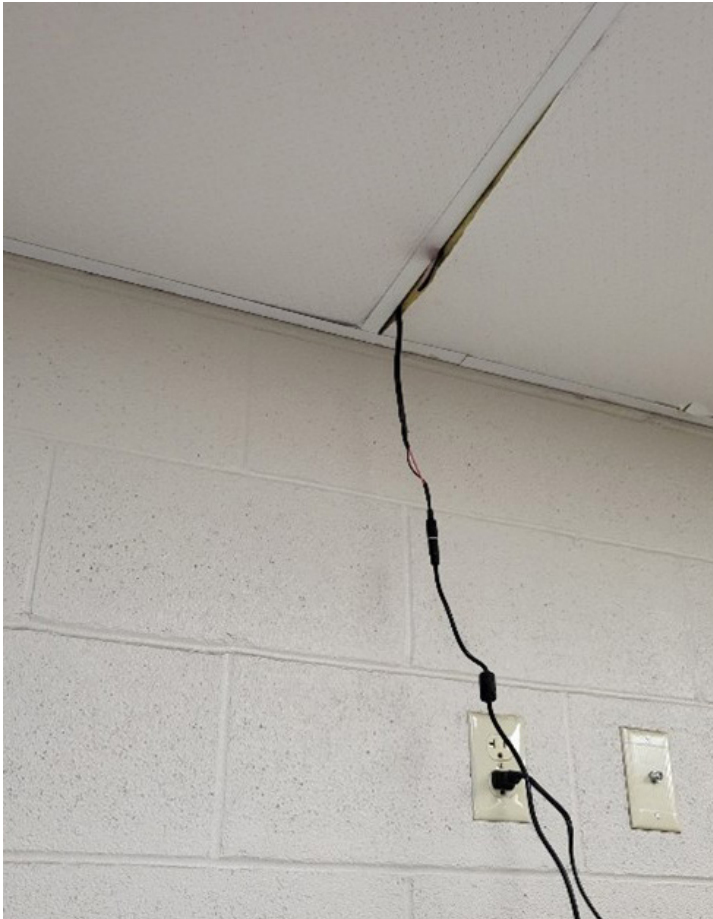
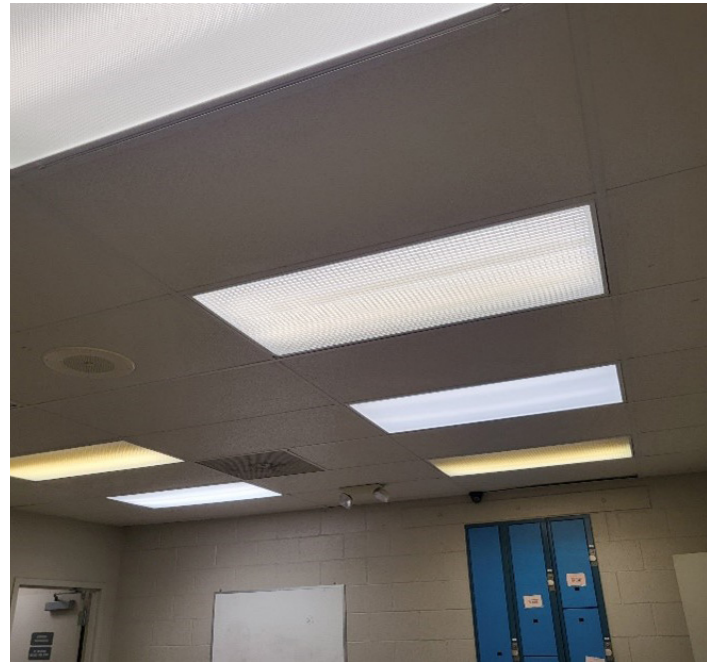
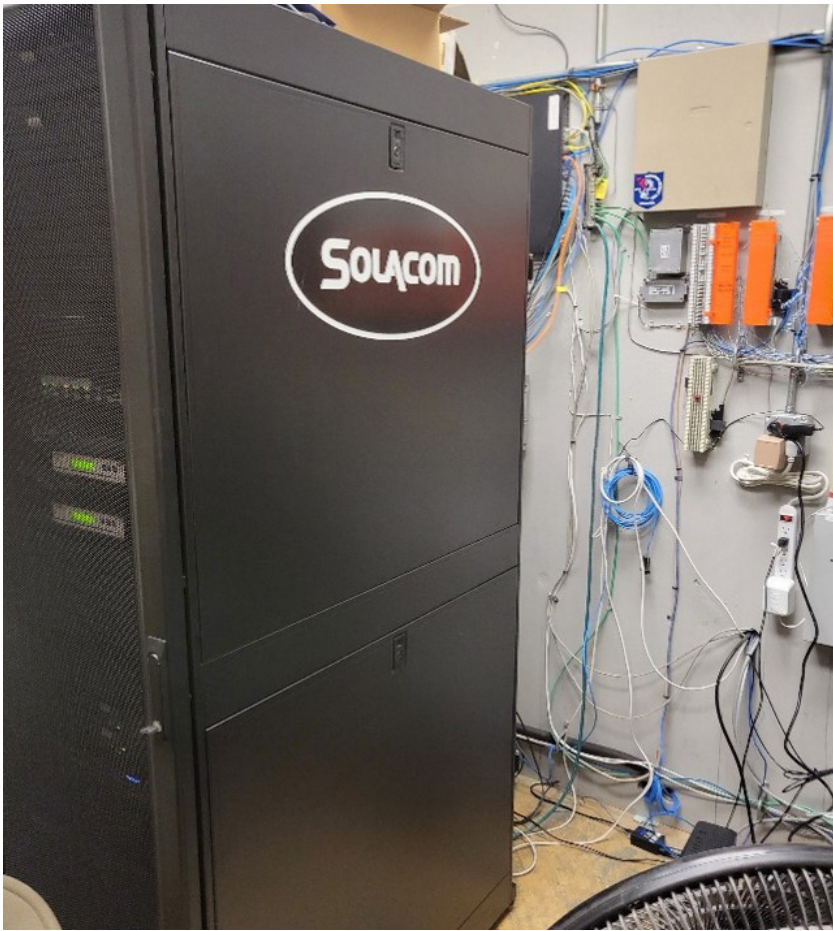
The condition of lighting and receptacles in the building is as expected for a building of this age. Numerous light fixtures have broken or discolored lenses, bulbs that have burned out, or simply don't work. Several receptacles were observed to be broken, with exposed live parts. Cords were observed going through ceilings, which is a code violation (NEC 400.12) Repairs can be made for all this equipment, but the repairs will be necessary in the majority of the building.

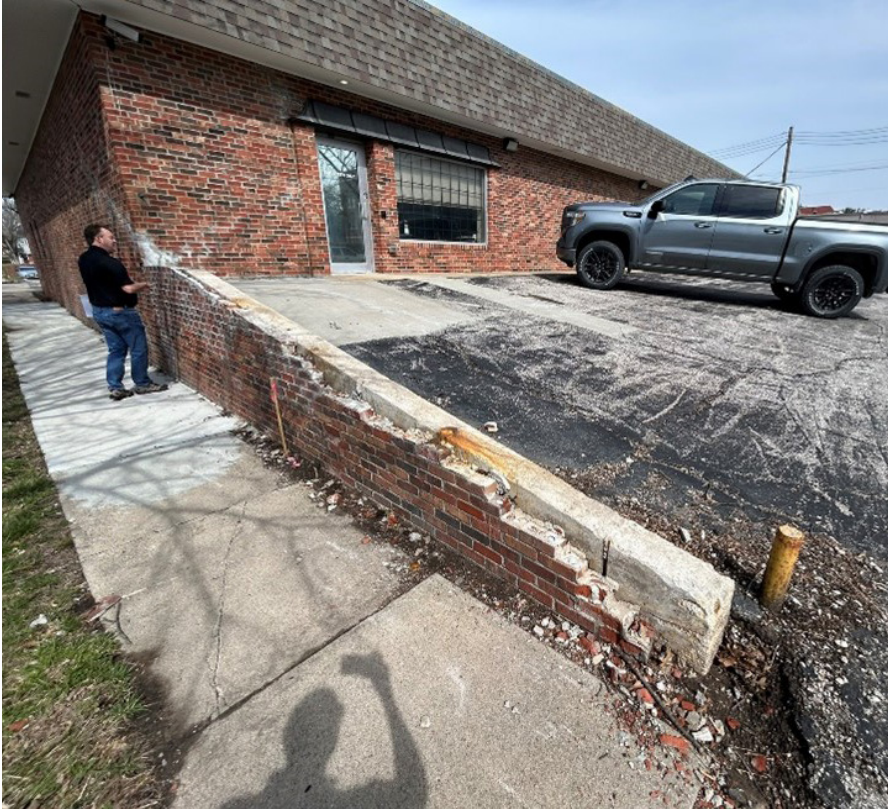
Existing site retaining wall is in poor condition. The steel reinforcement elements have been exposed and rust stains clearly shown. The brick cladding has failed to the point that large pieces have broken off and crumbled. Brick efflorescence is also clearly present which signifies water has penetrated the wall assembly.

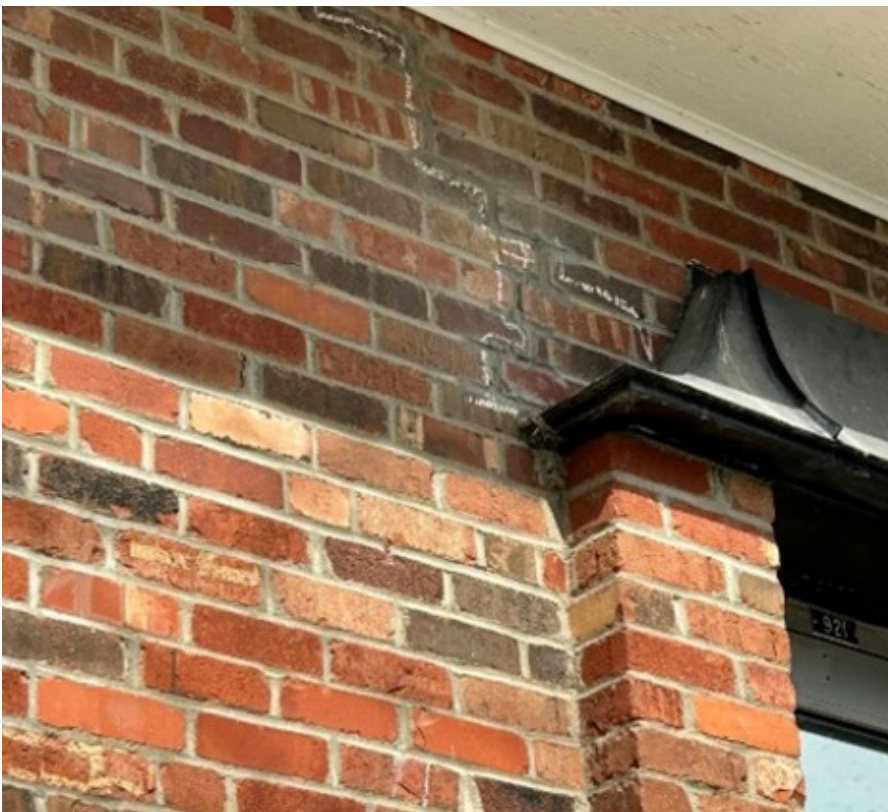
Settlement issues are present on the south façade near the existing entrance door. Cracks within the brick wall seem to have had some minor repair.
