THE CITY OF CHILLICOTHE, MISSOURI  
POLICE DEPARTMENT HEADQUARTERS

# **FACILITY ASSESSMENT**

613 WALNUT ST. CHILLICOTHE, MO 64601

**DATE COMPLETED:** April 8, 2024

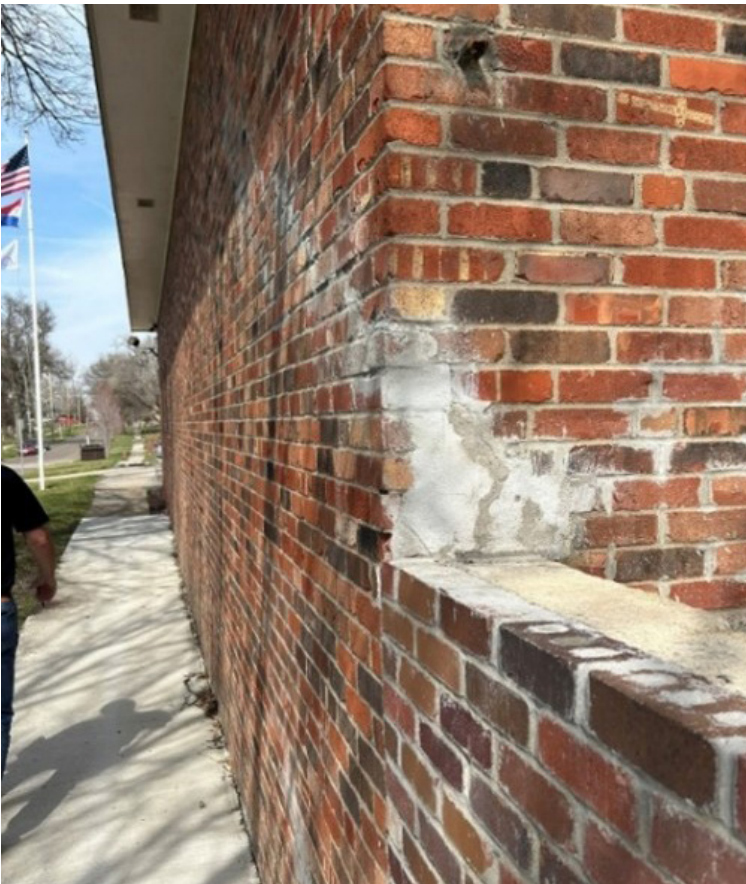
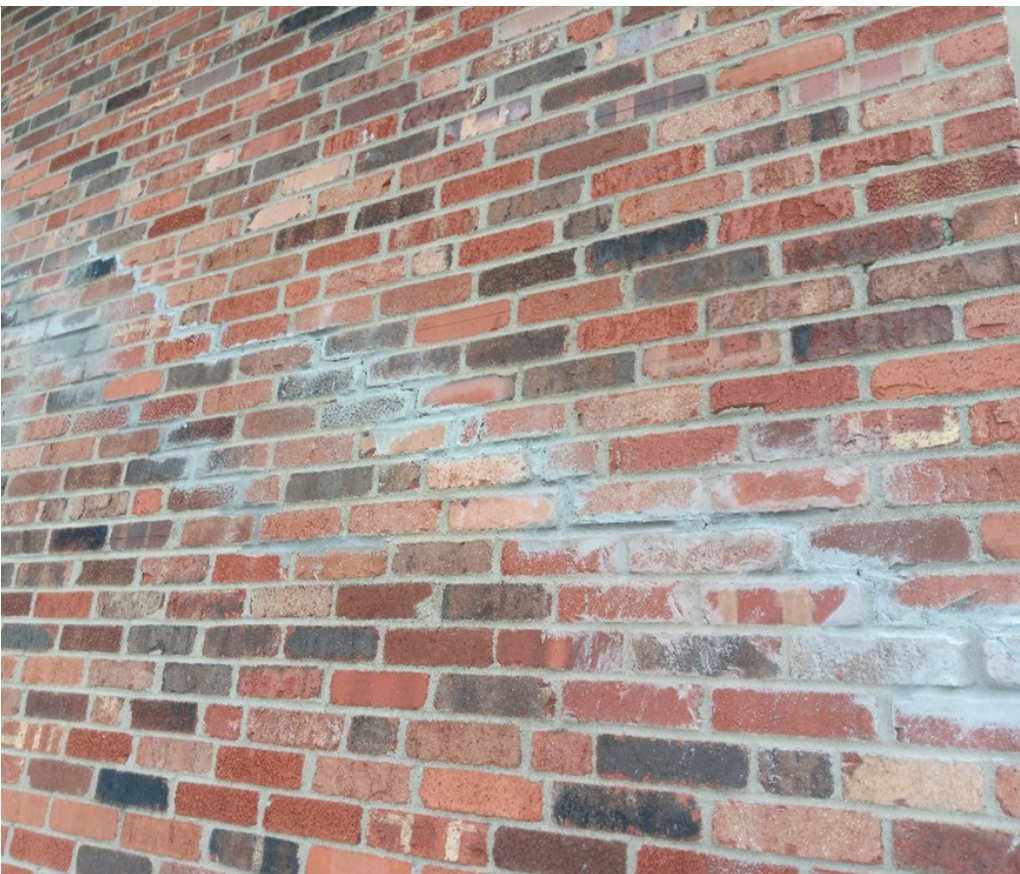
Significant settlement and minor repair work of the brick facade has been done on the southwest corner of the building.

Brick façade settlement on the west façade has occurred with minor repair. The entire west building façade could have settlement issues. Unknown if there's foundation failures causing the settlement.

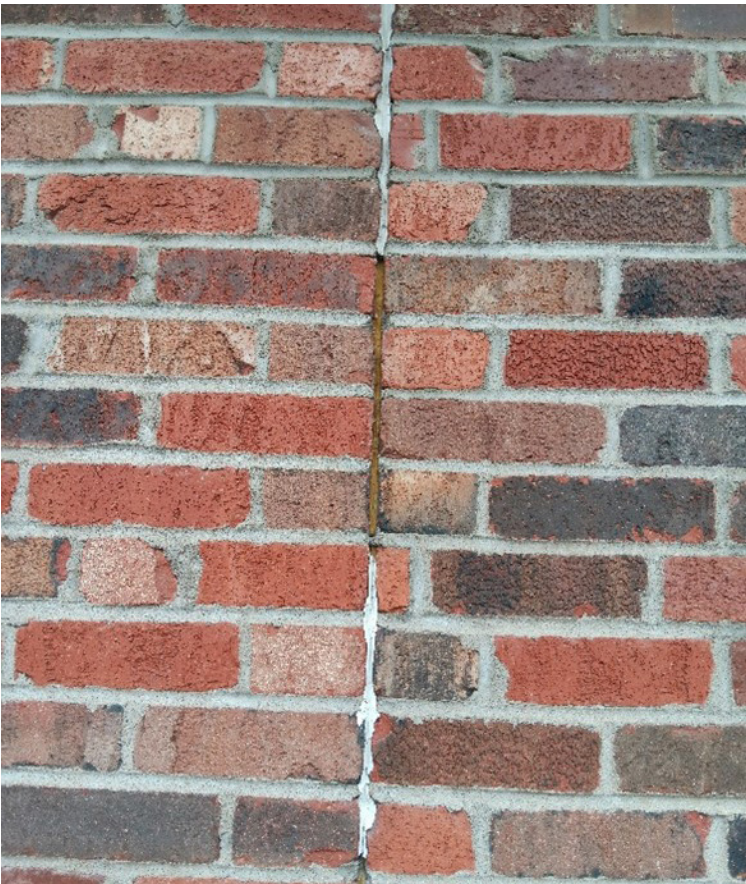
Brick control joints need to be re-repaired and recaulked.

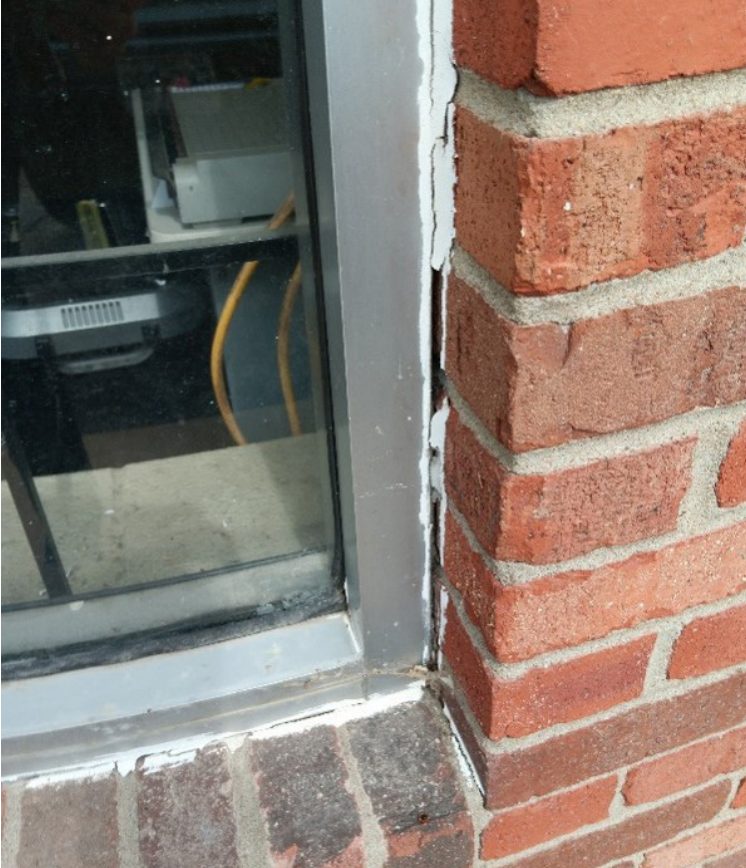
Caulk joints between window systems and brick cladding have failed.

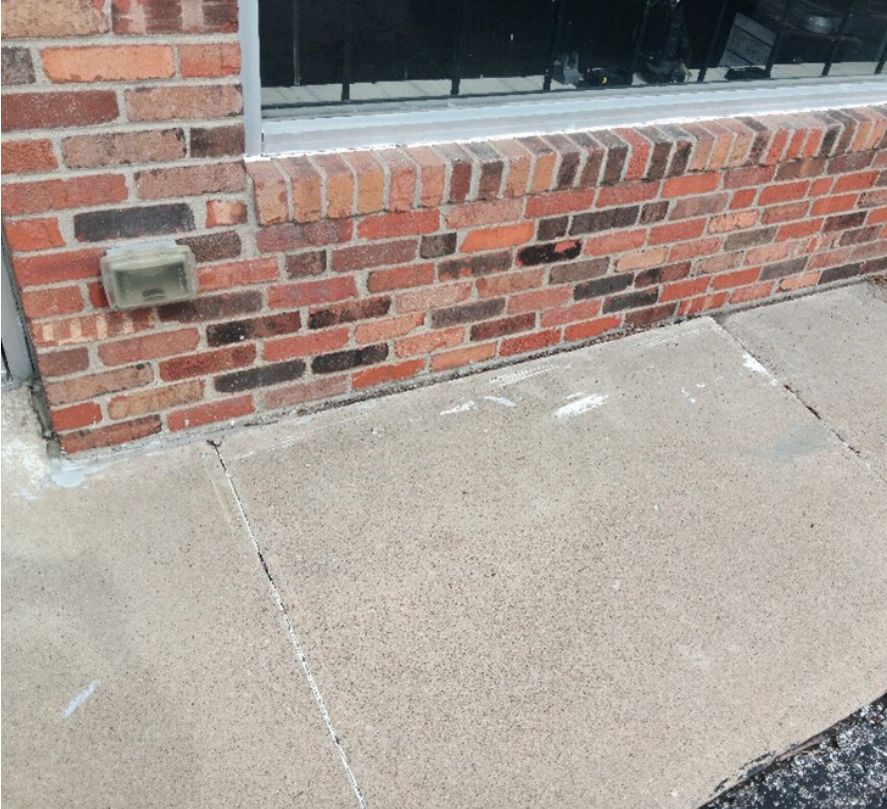
Existing sidewalk elevation on the outside of the building is actually higher than the interior finish floor elevation. This relationship could allow for water intrusion from the exterior to the interior. The exterior wall is acting as a retaining wall and also serving as the only barrier to keep water out. It is preferred to keep exterior grade below interior finish grade.

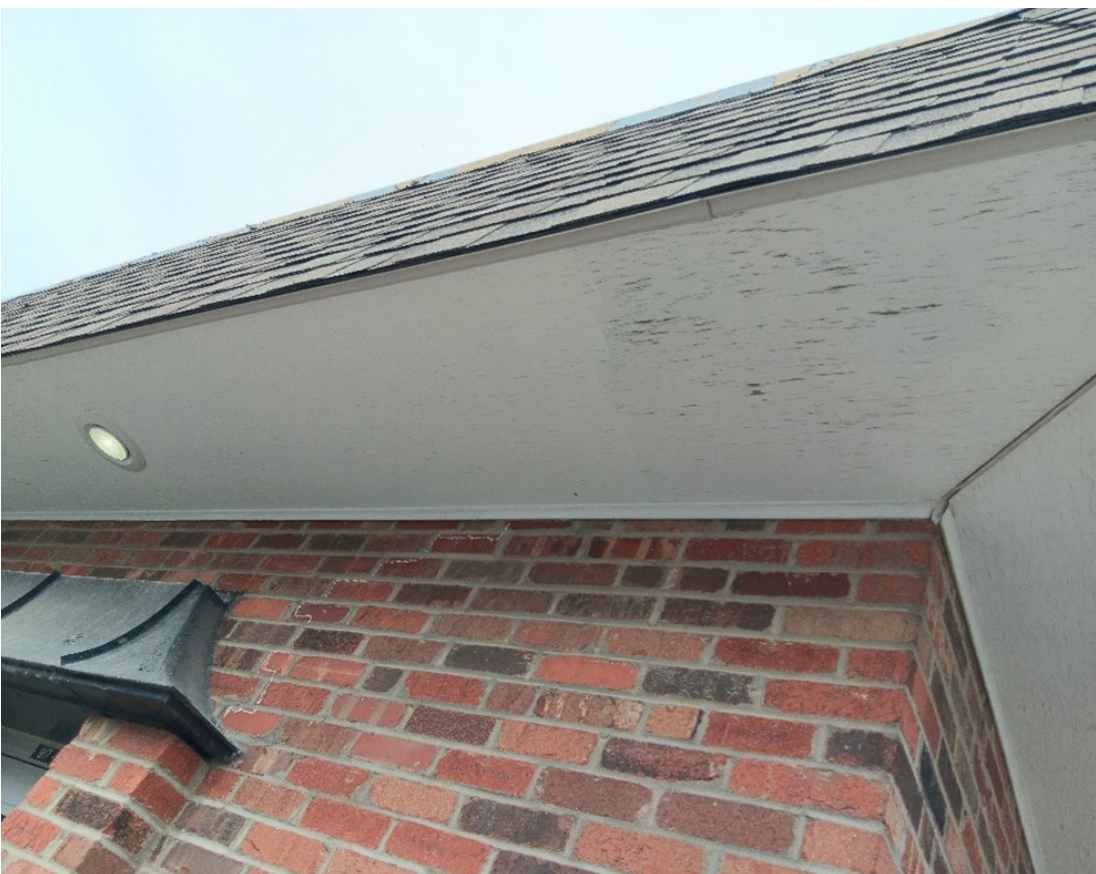
Soffit damage is present. Repairs are needed.

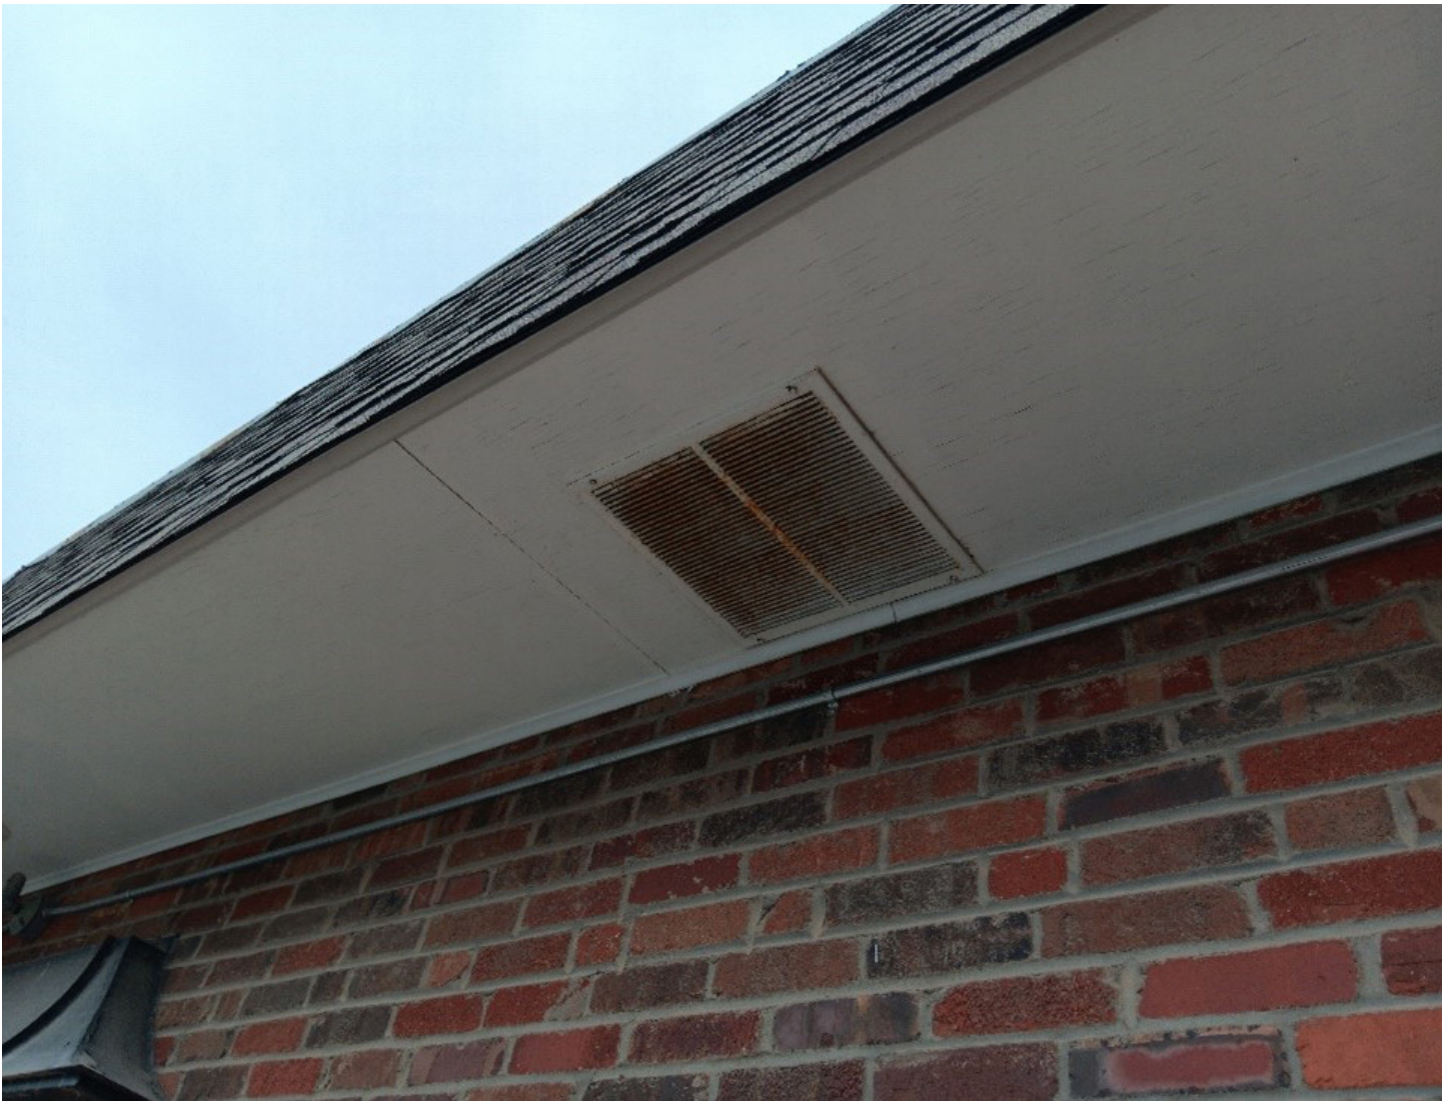
Soffit vents are rusted and need to be placed.

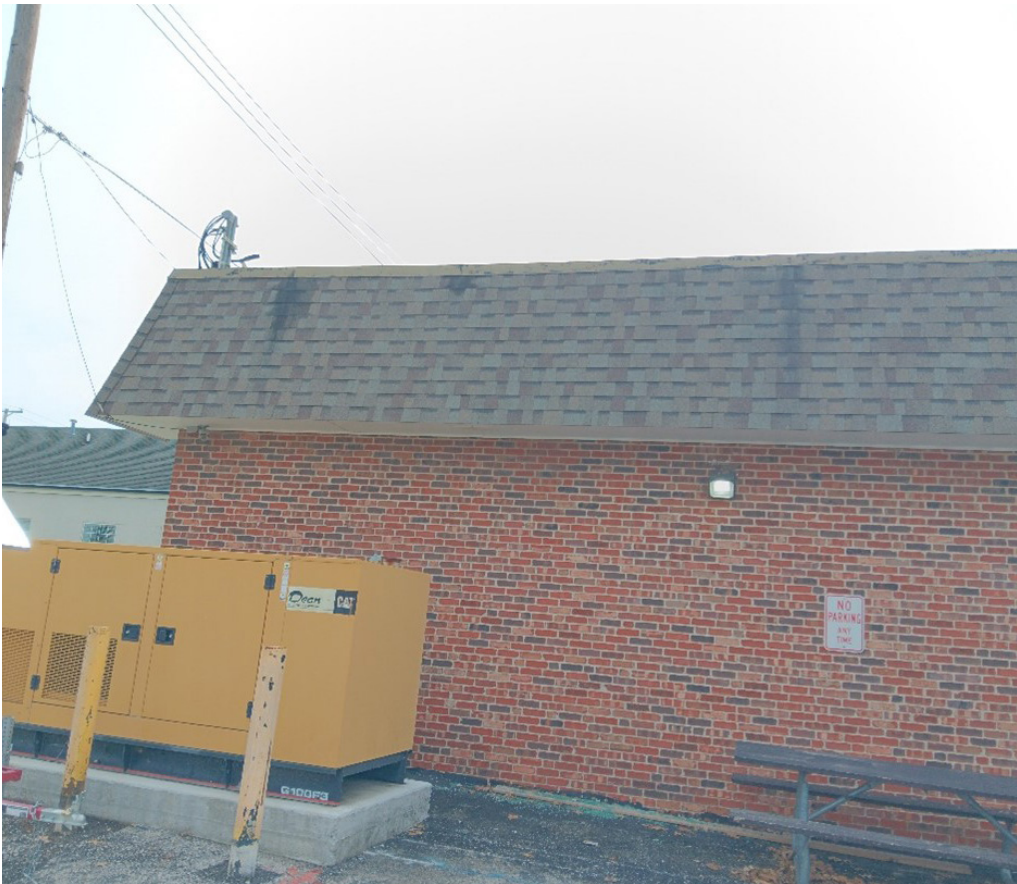
Mansard roofs have water infiltration, surface stains, and damage from coping cap failures along the top of the wall.

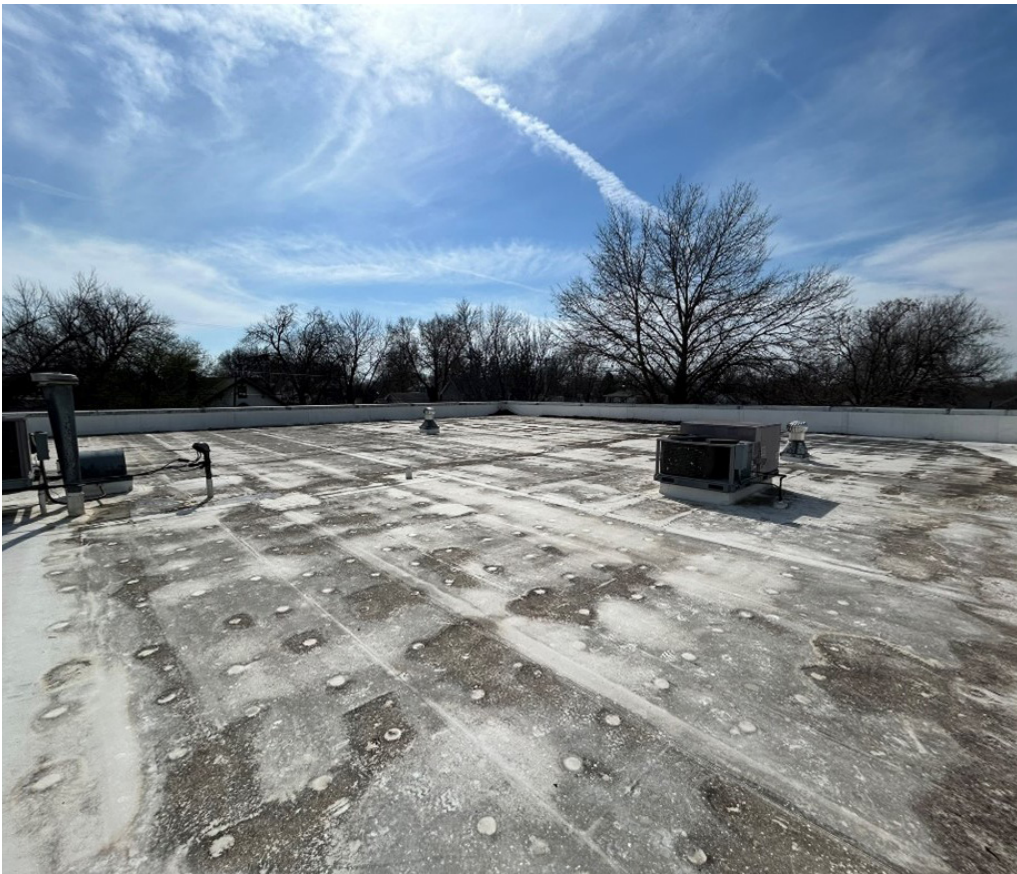
Roof membrane has significant wear and tear.

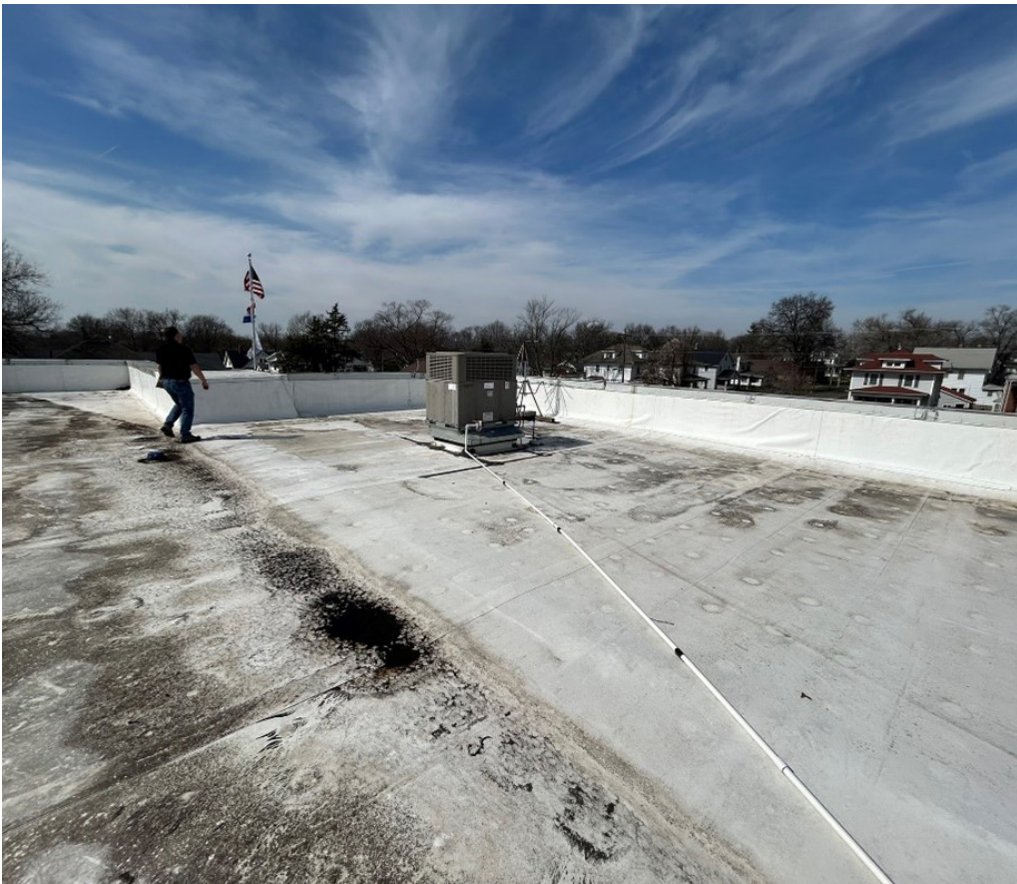
Roof ponding is occurring where roof is not properly sloped to drains. This increases the chances of roof failures and in turn building leaks.

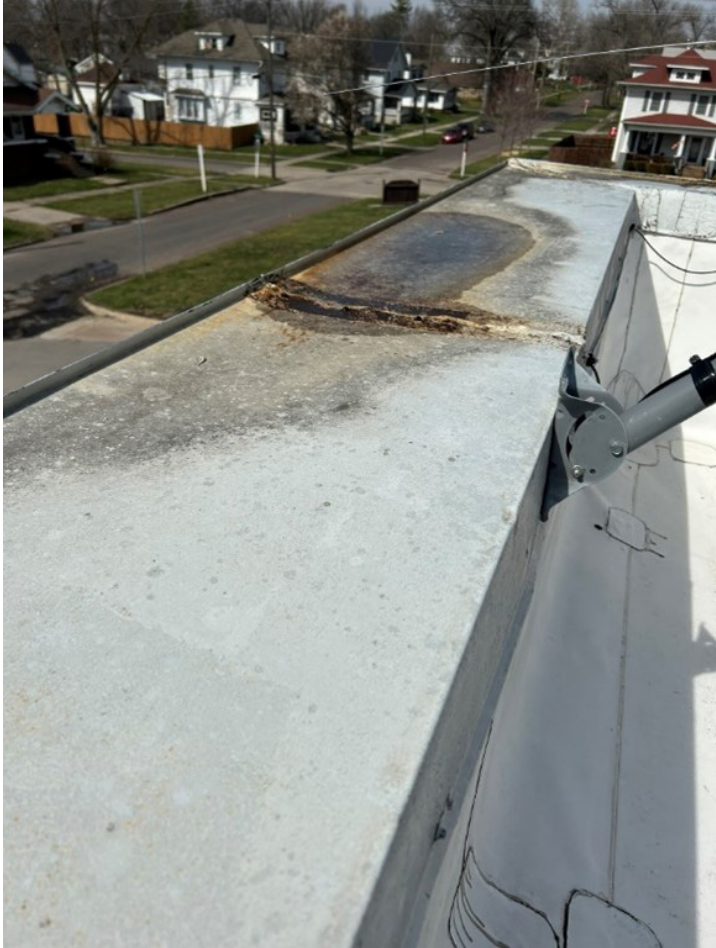
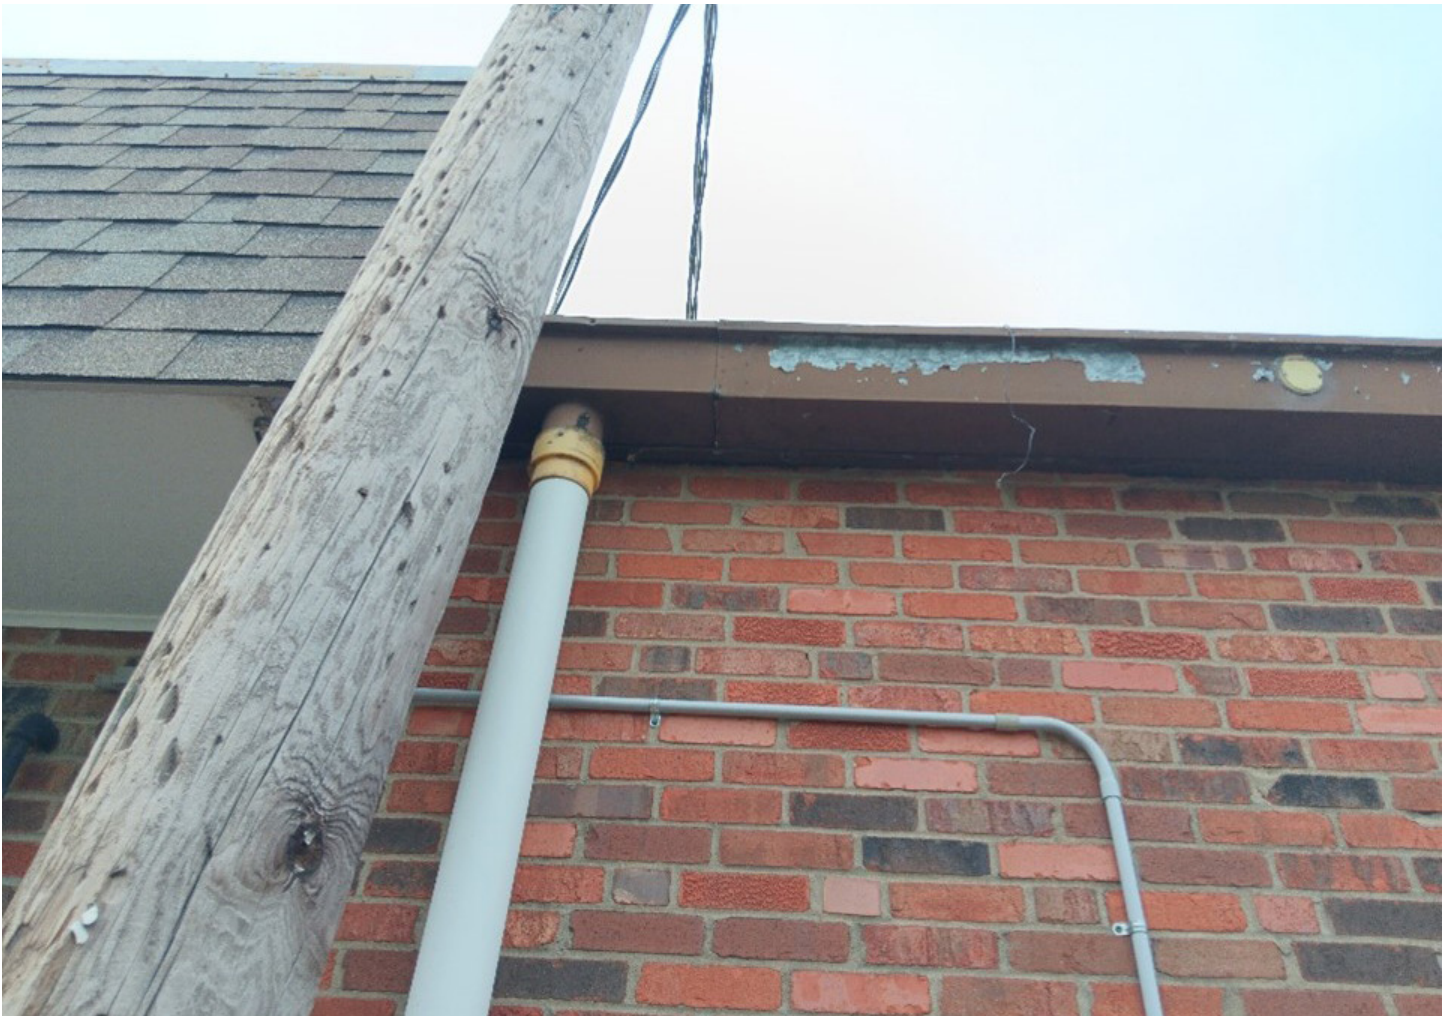
Exterior wall roofing coping cap has significant damage including material failures, water ponding, and rust. This could lead to rain water entering the wall cavity and in turn into the building.

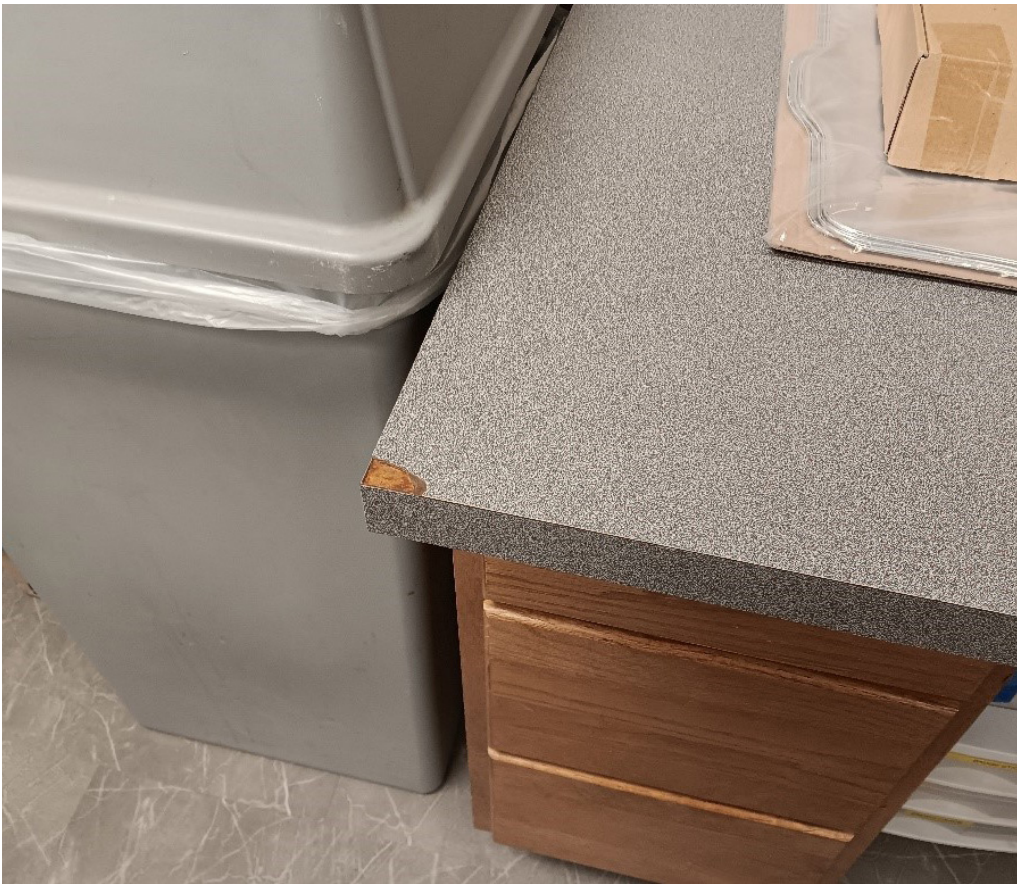
Casework failures are present including countertop damage of the plastic laminate.

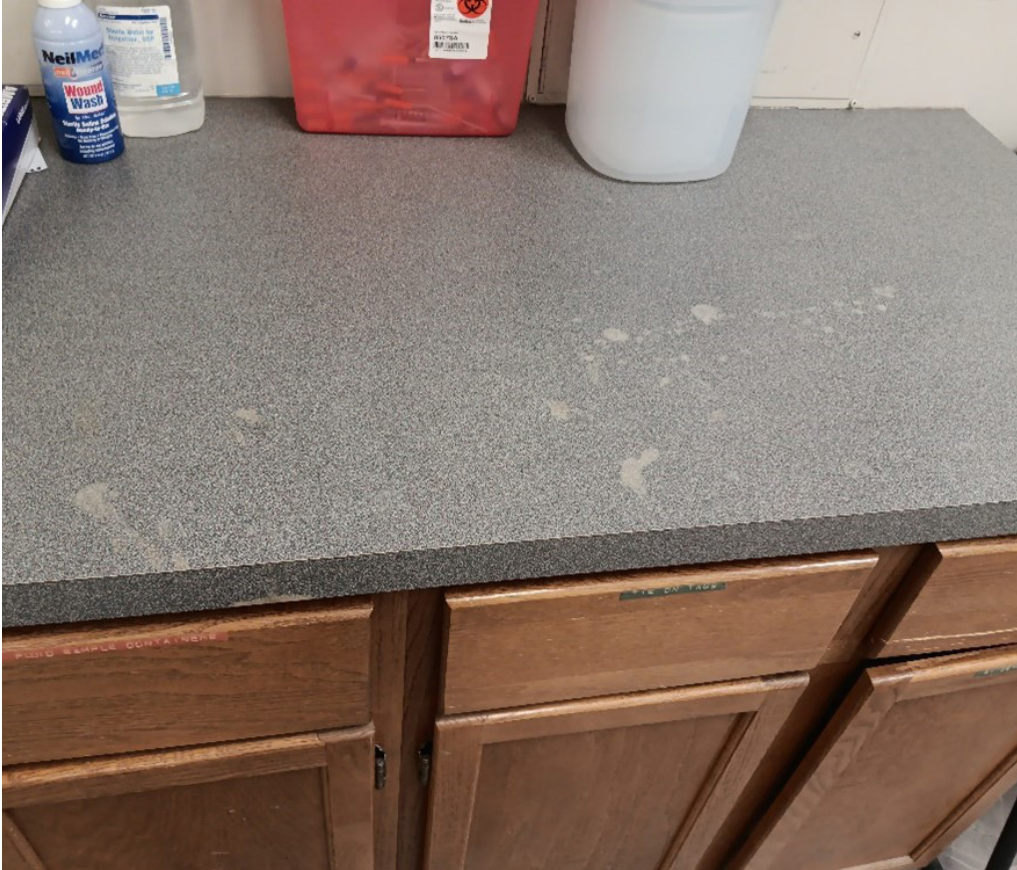
Countertop and cabinet damage is present throughout the facility.

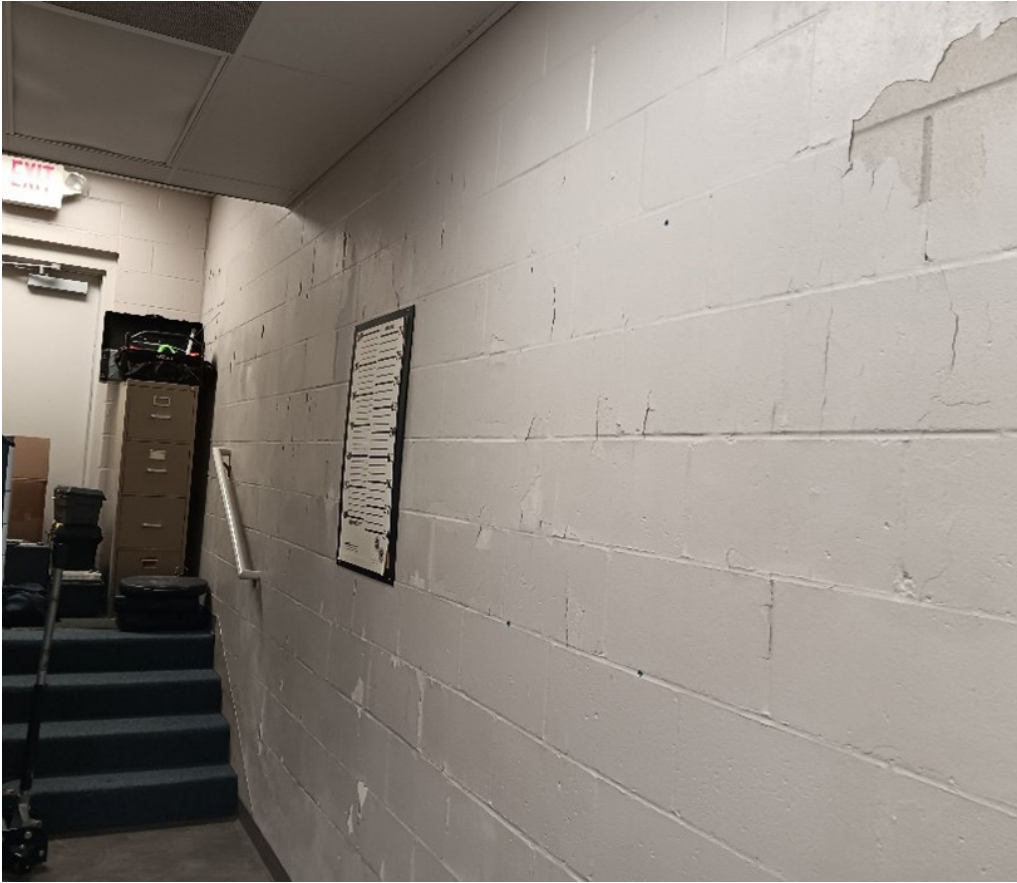
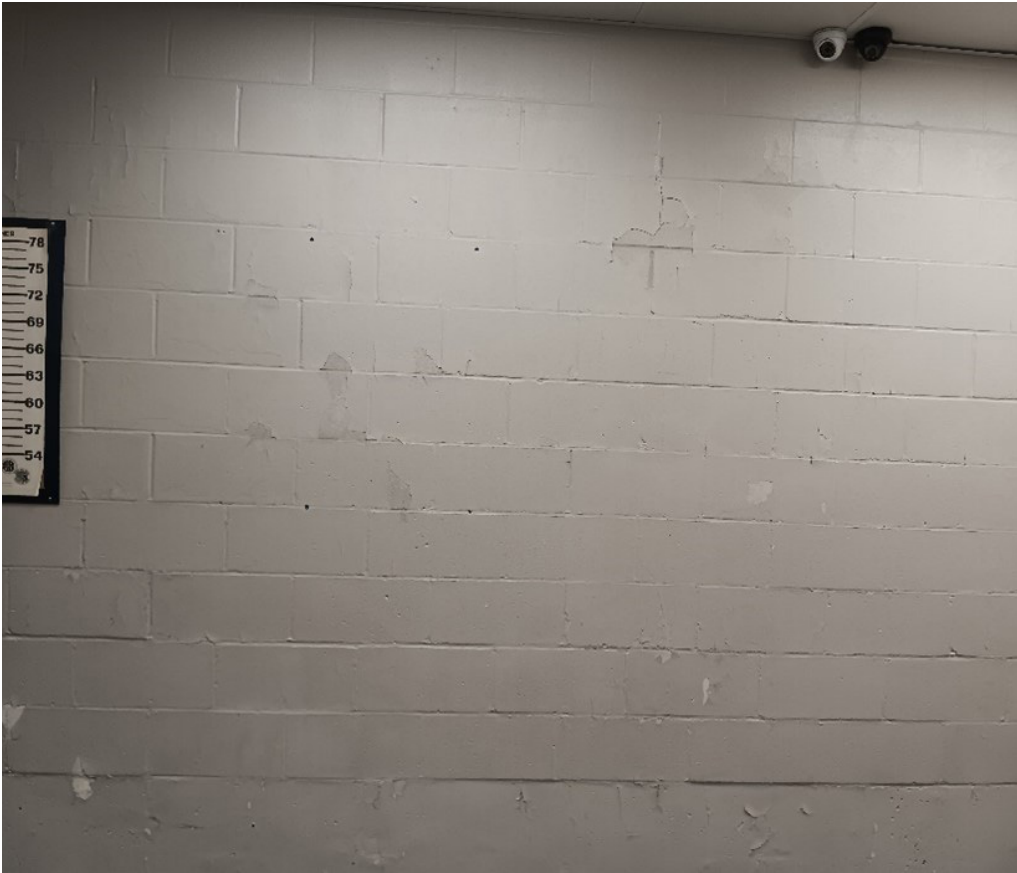
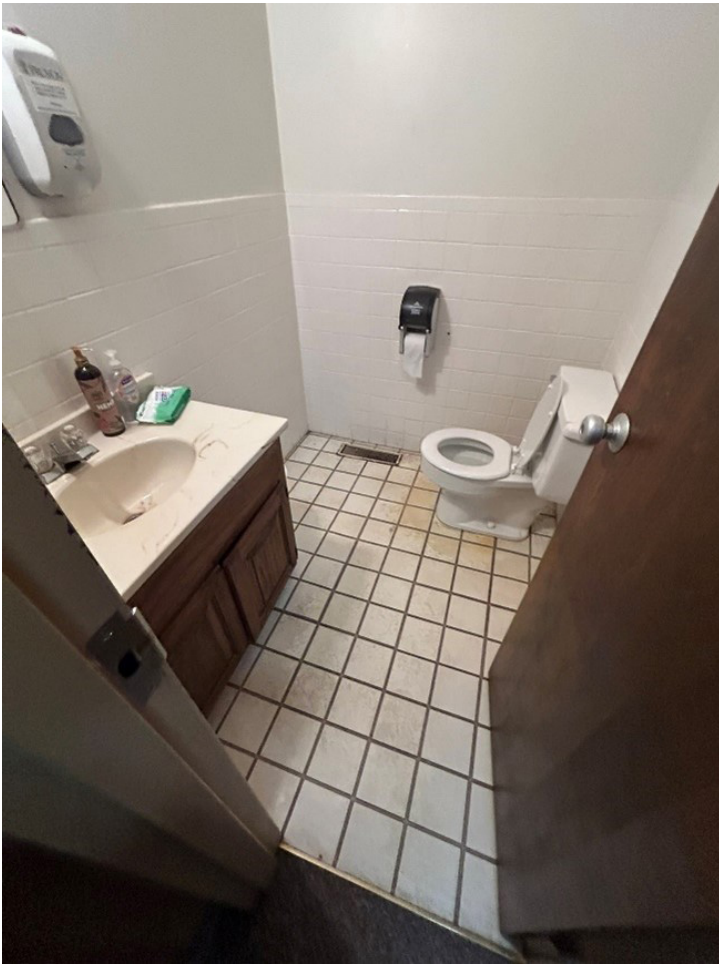
Existing concrete masonry unit walls have water damage leading to surface failures including some surface cracking as well as paint peeling from the surface.

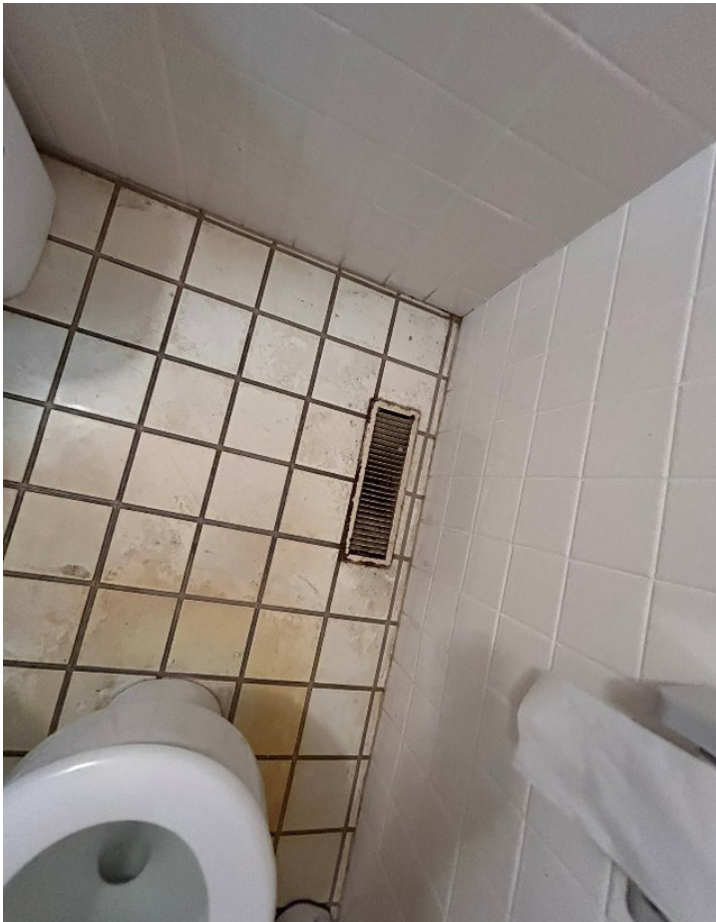
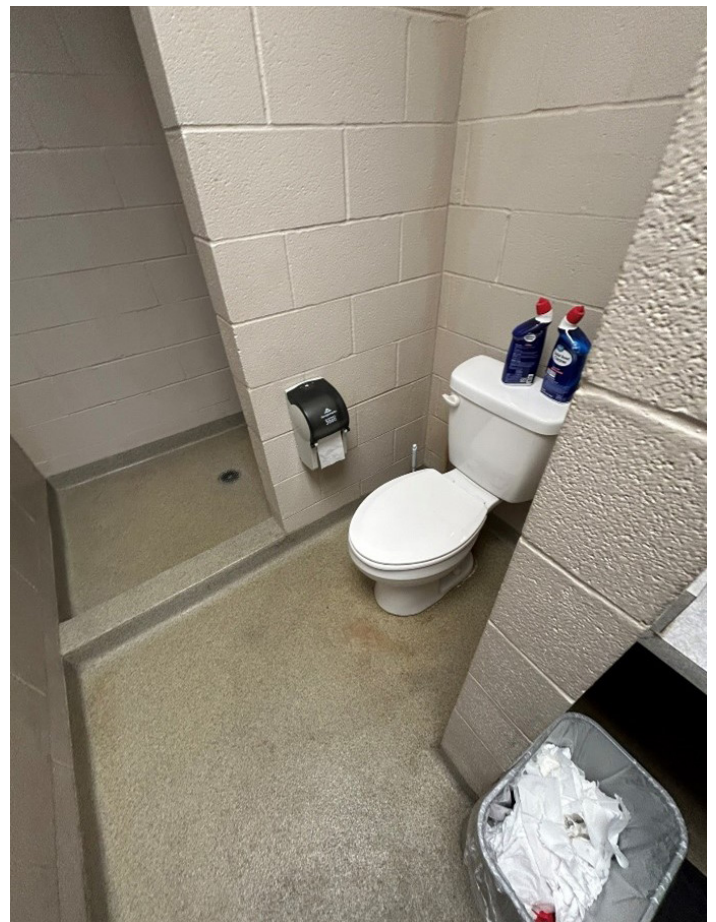
Restrooms are in poor condition. Flooring, wall finishes, plumbing fixtures, and ceilings need to be replaced. Existing mechanical diffusers need to be replaced.

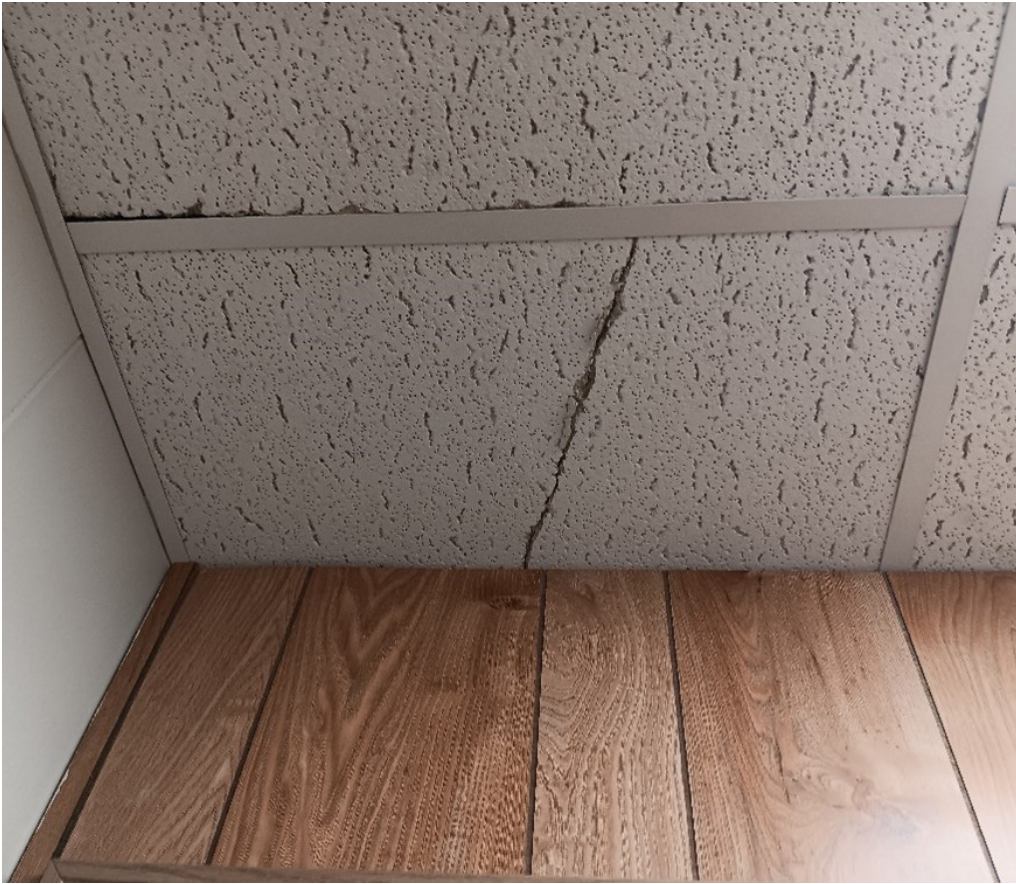
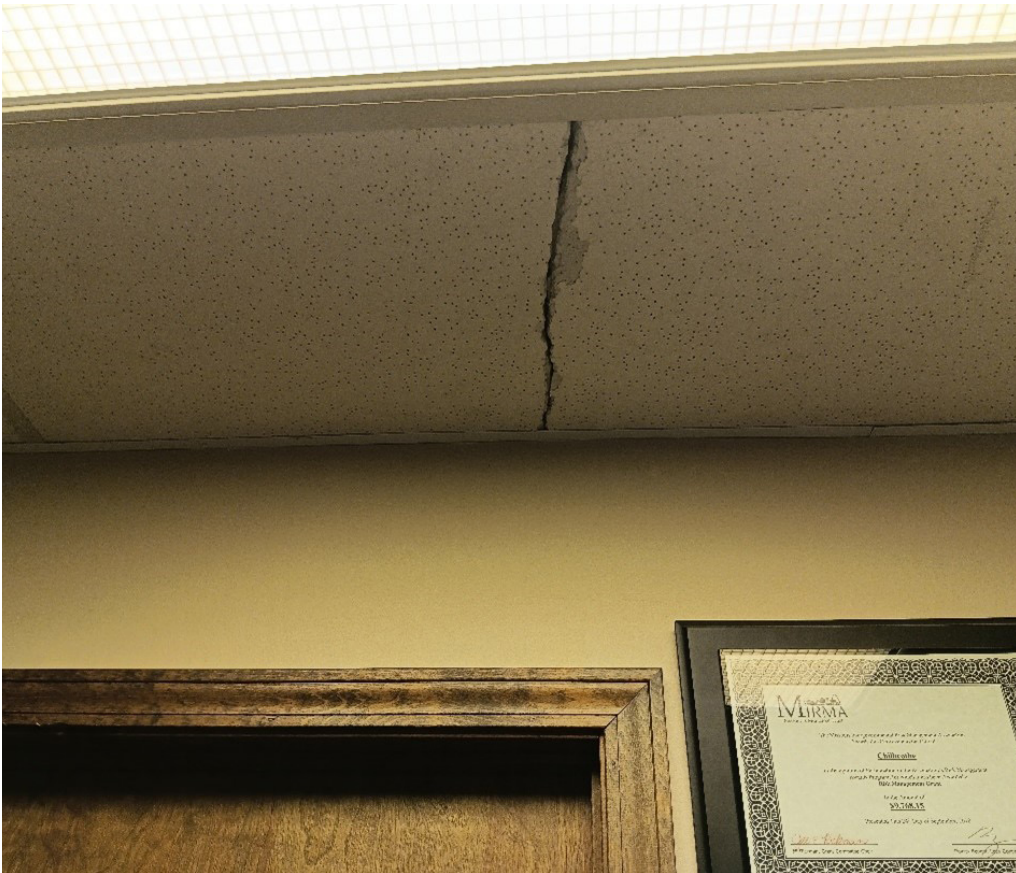
Various ceiling systems are in disrepair. Ceiling tiles are broken, damaged, or missing throughout the facility. Cracking of tiles may be an indication of interior wall movement due to structural issues such as building settlement.

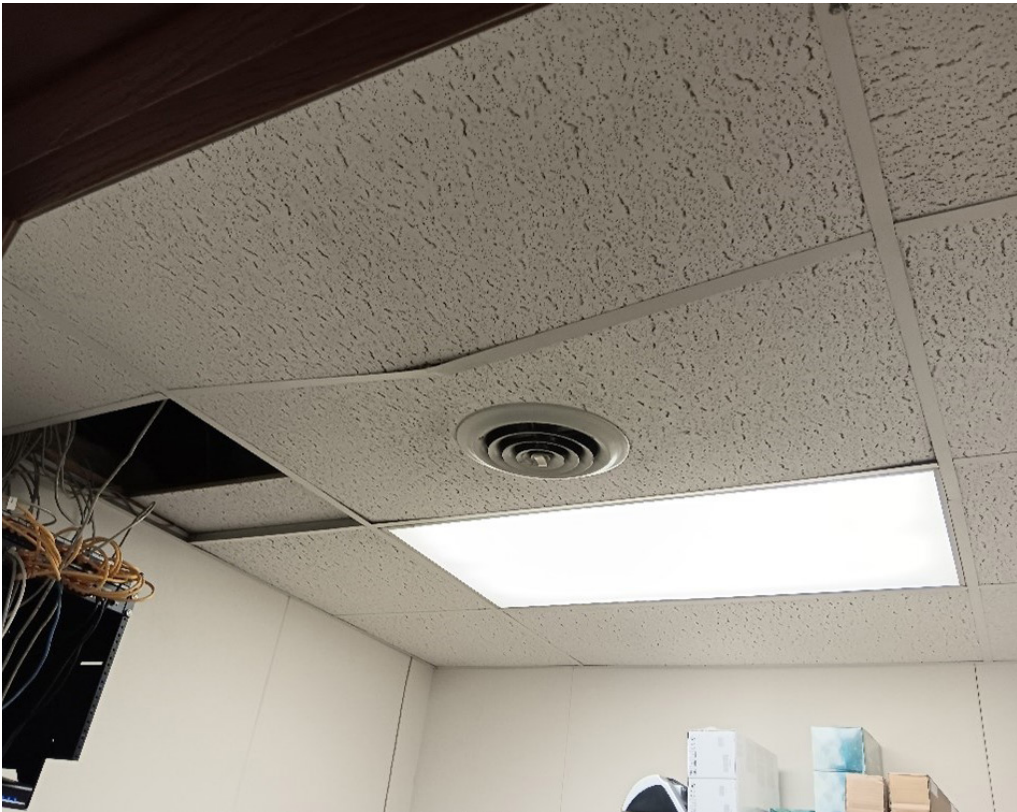
Ceiling grid systems are failing in various areas.

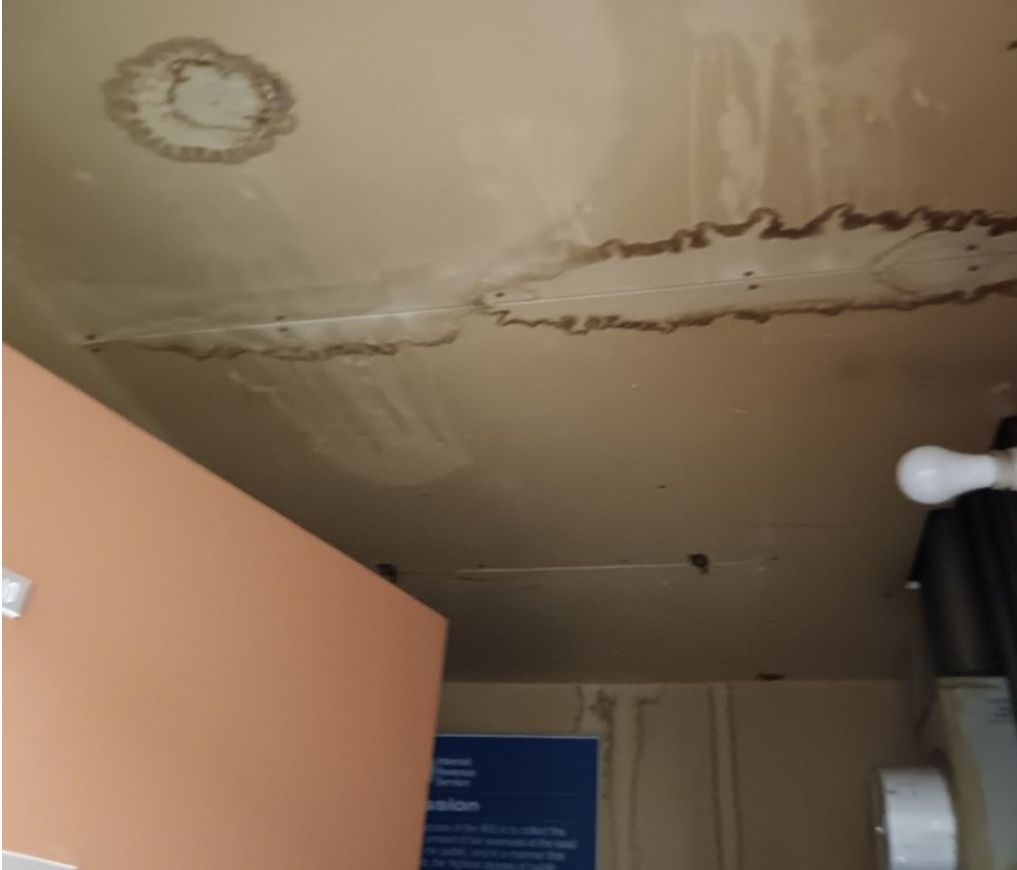
Drywall ceiling has extensive water damage. This is probably due to roof leaks in this area.

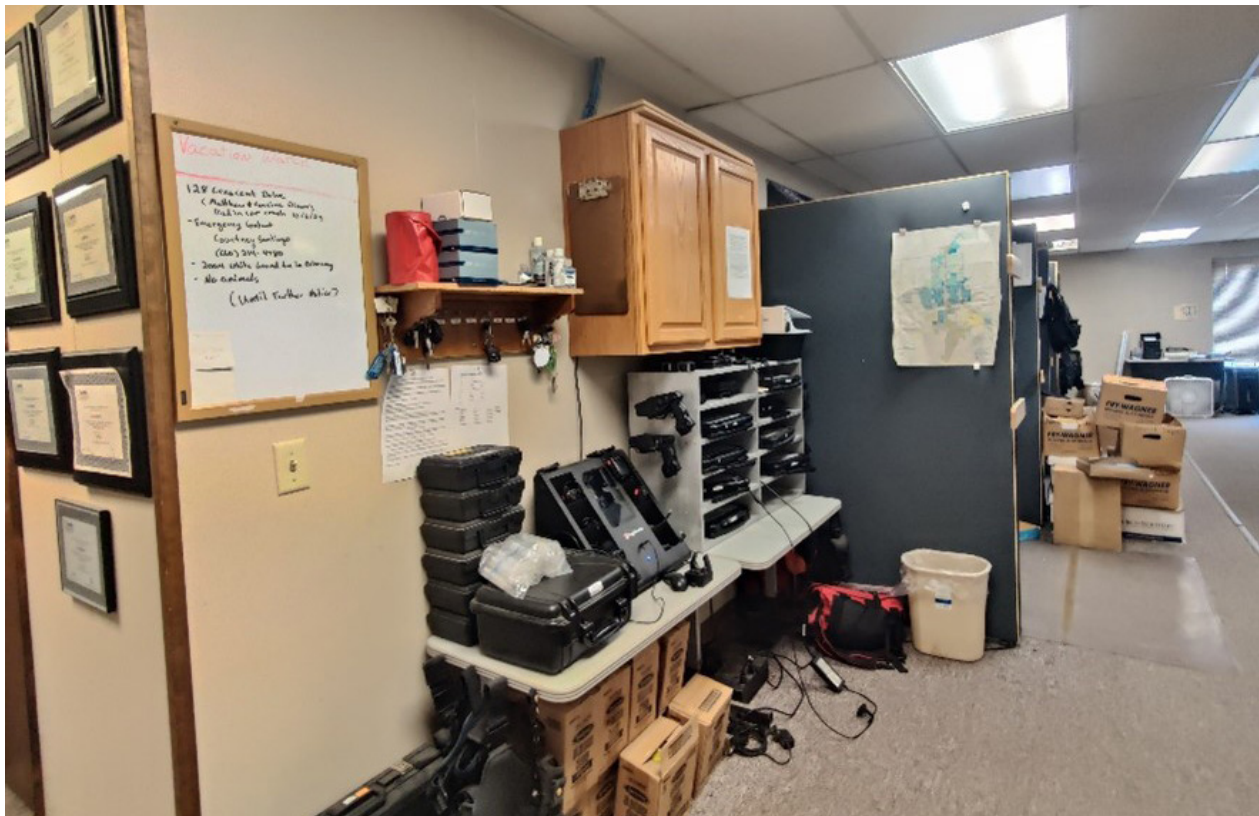
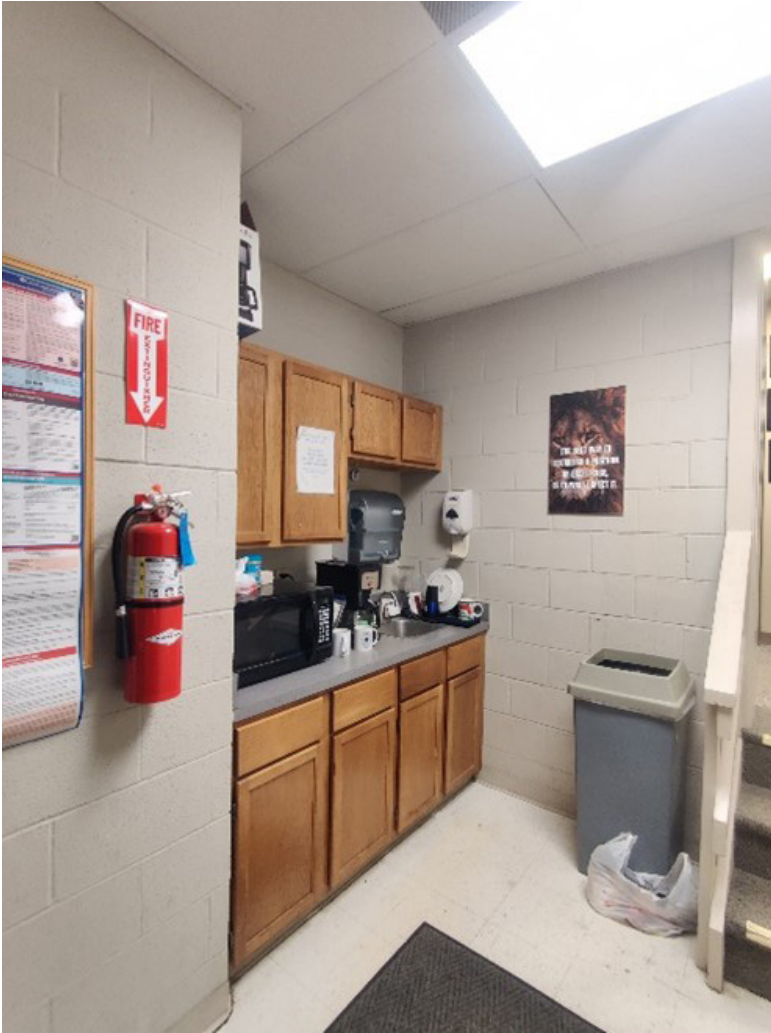
Patrol officer work area is significantly smaller than needed. There is not enough space for staff mailboxes, radio charging, and staff supplies. Various items are located on the floor due to lack of storage space.
