THE CITY OF CHILLICOTHE, MISSOURI  
POLICE DEPARTMENT HEADQUARTERS

# **FACILITY ASSESSMENT**

613 WALNUT ST. CHILLICOTHE, MO 64601

**DATE COMPLETED:** April 8, 2024

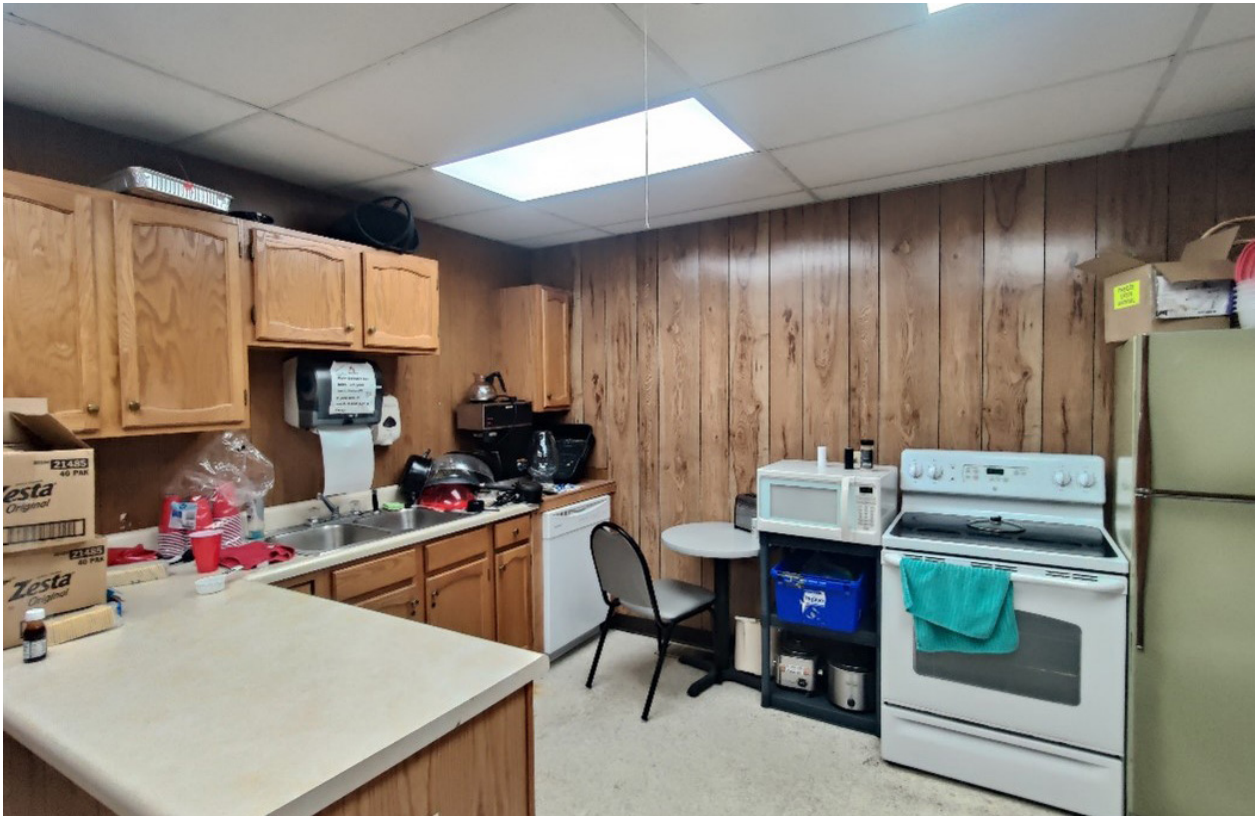
Breakroom areas are not large enough to function for staff. Storage is lacking. Appliances appear to be beyond their usable life

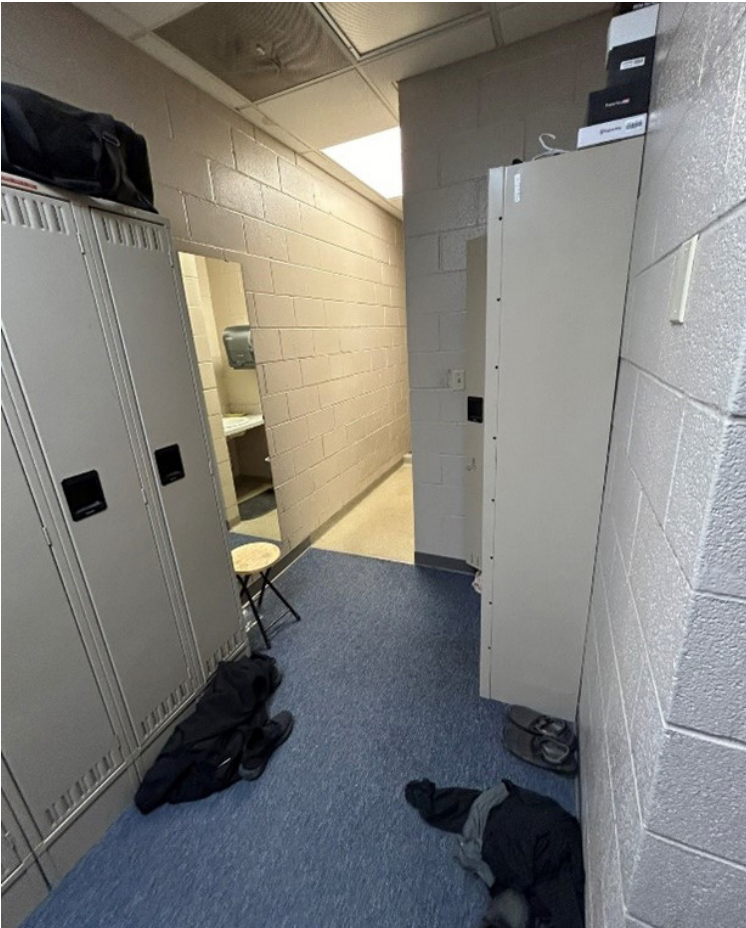
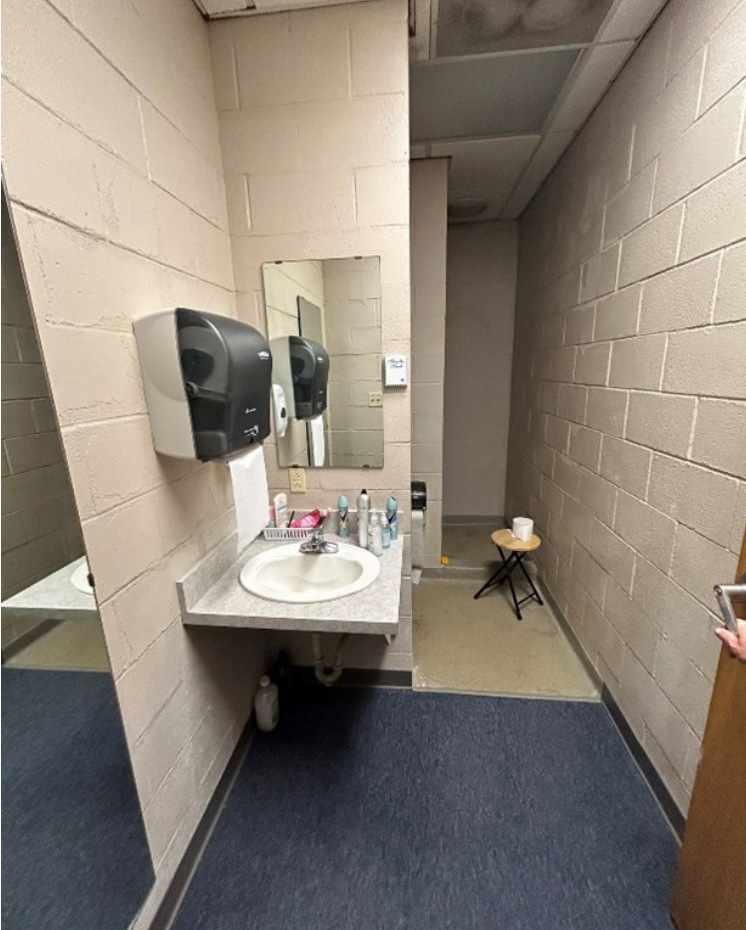
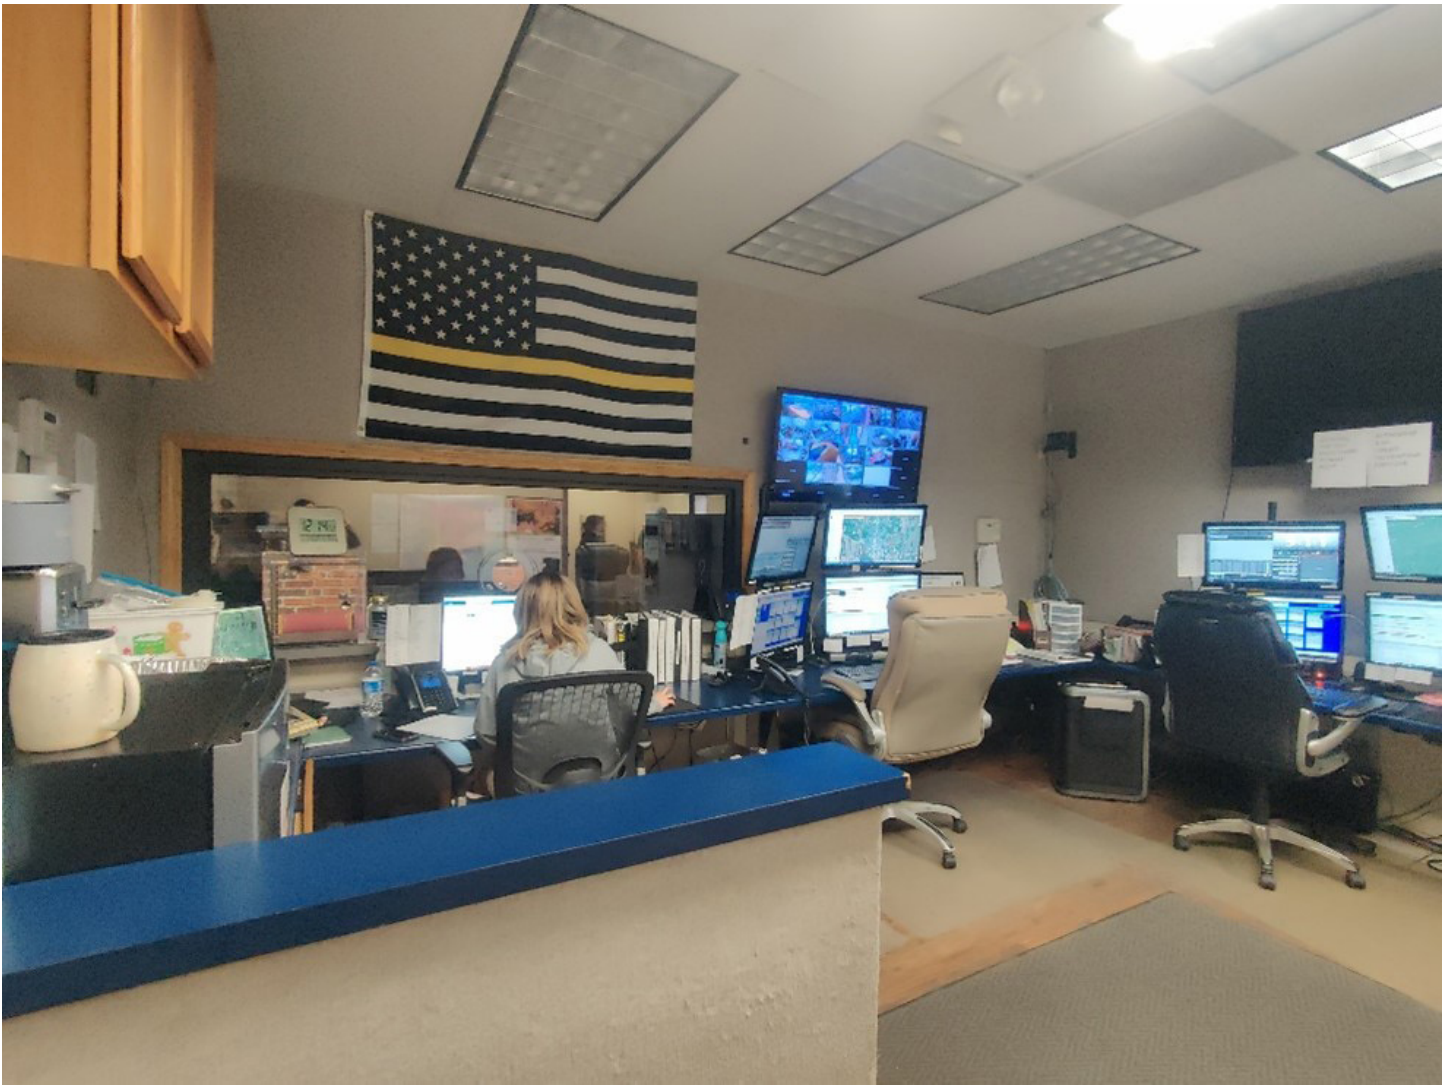
Restroom, locker, and shower facilities are inadequate. Dedicated private shower facilities are not provided. Female staff shares locker area with male staff without any ability for privacy. Storage space is undersized and various items are placed on the floor.

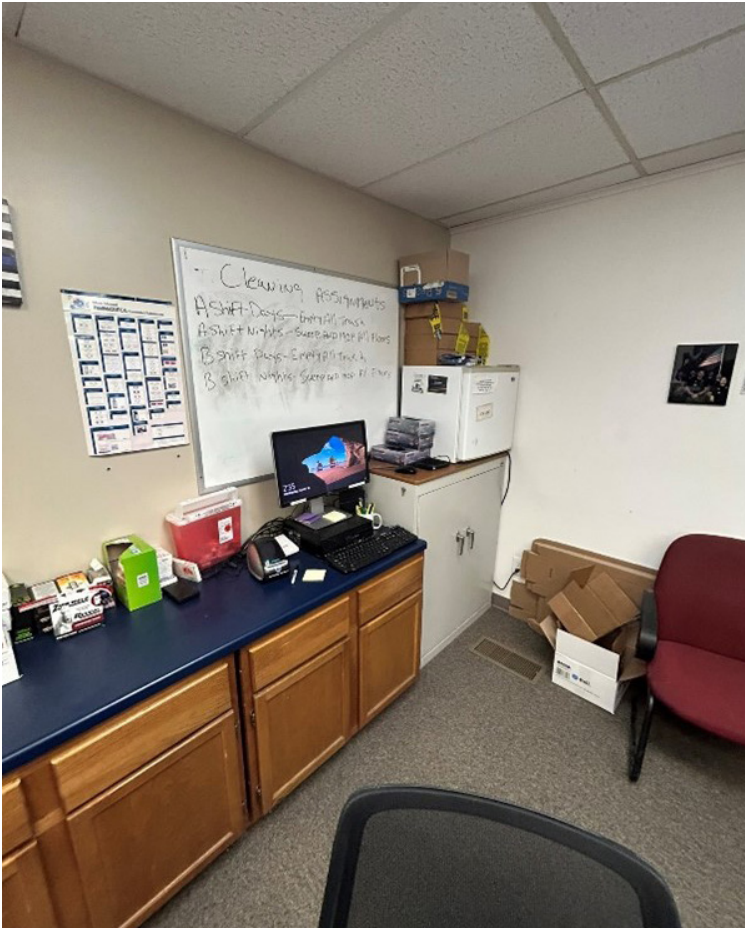
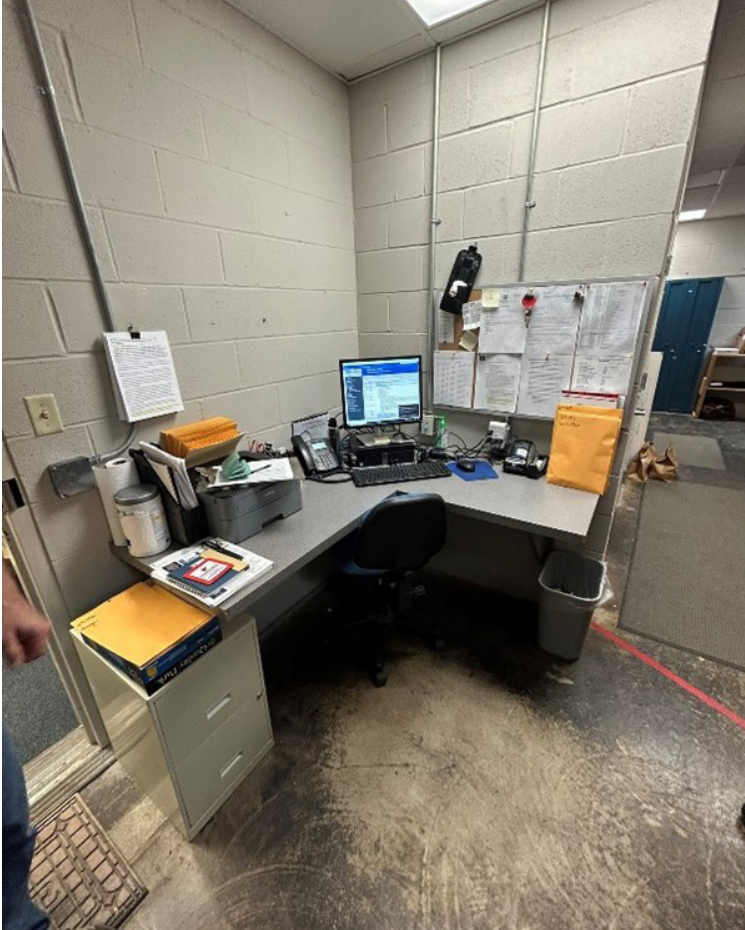
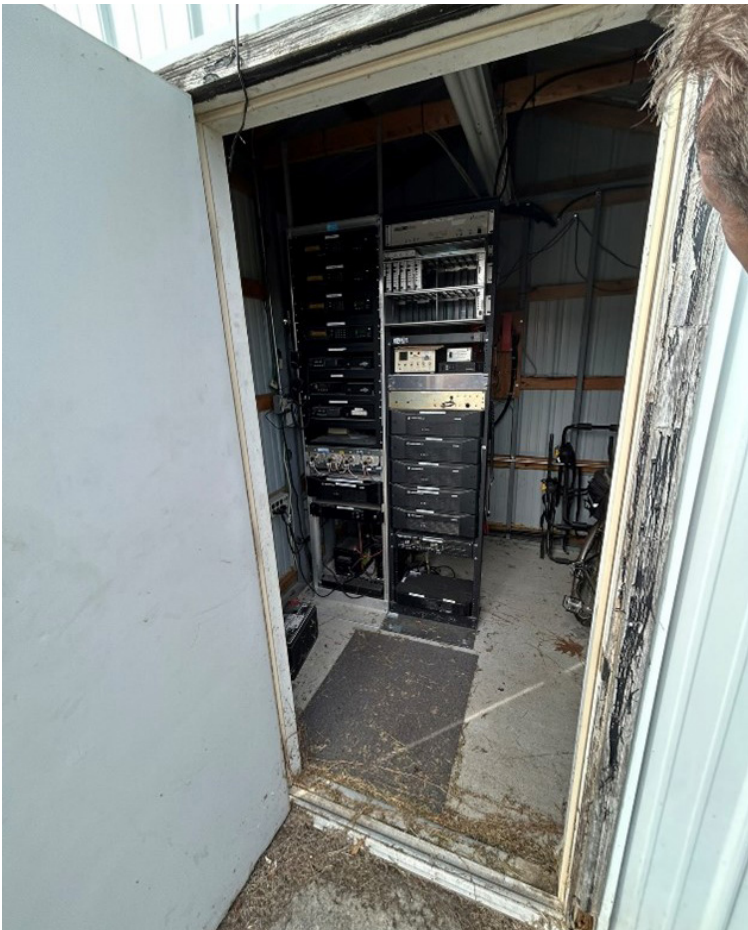
Property processing and intake areas are insufficient. These spaces should be much larger and provided with proper exhaust systems to ensure the health of those utilizing these spaces. These spaces should also be located near patrol functions for efficiency. They should not be combined with officer work areas where containments could enter daily work spaces.

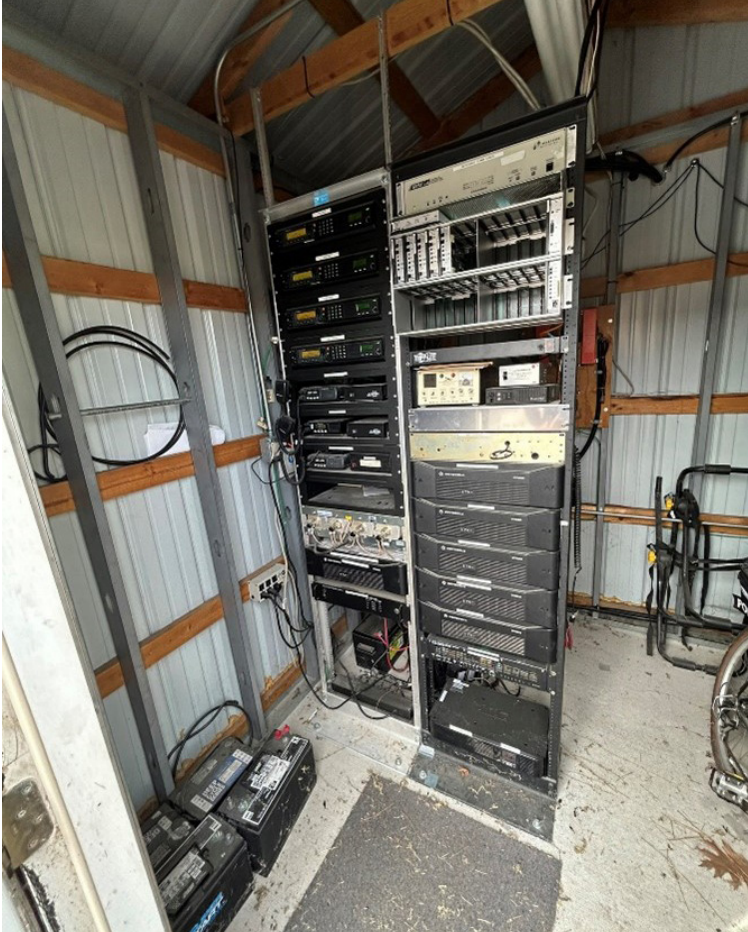
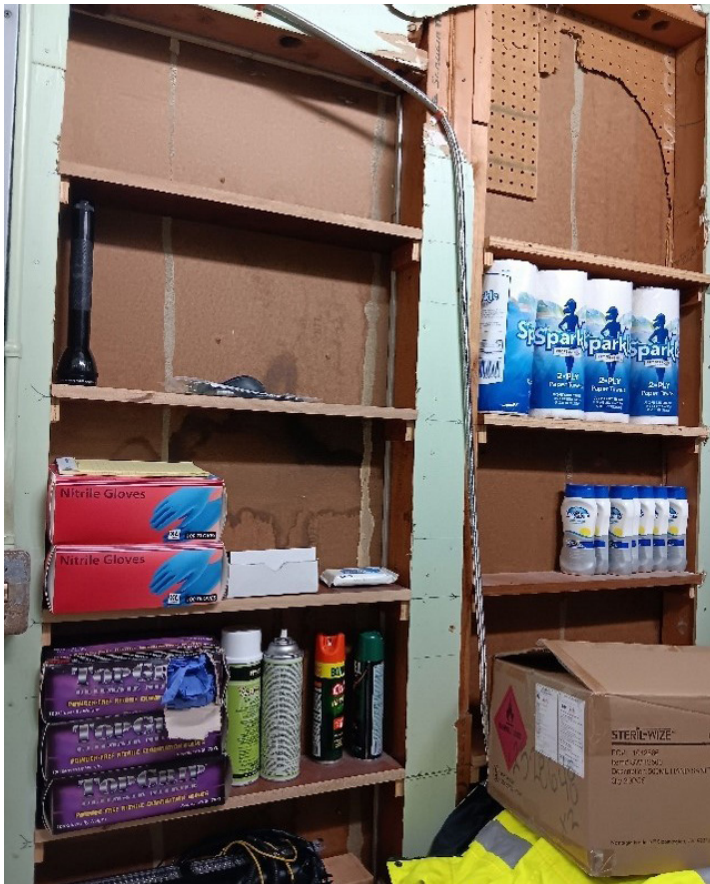
Radio tower technology equipment is located in a free-standing metal building structure located in the parking lot. This structure is not hardened or protected from potential storm damage. There is also not adequate HVAC to prevent equipment damage related to temperatures within the space. Dust and dirt could also damage this equipment,

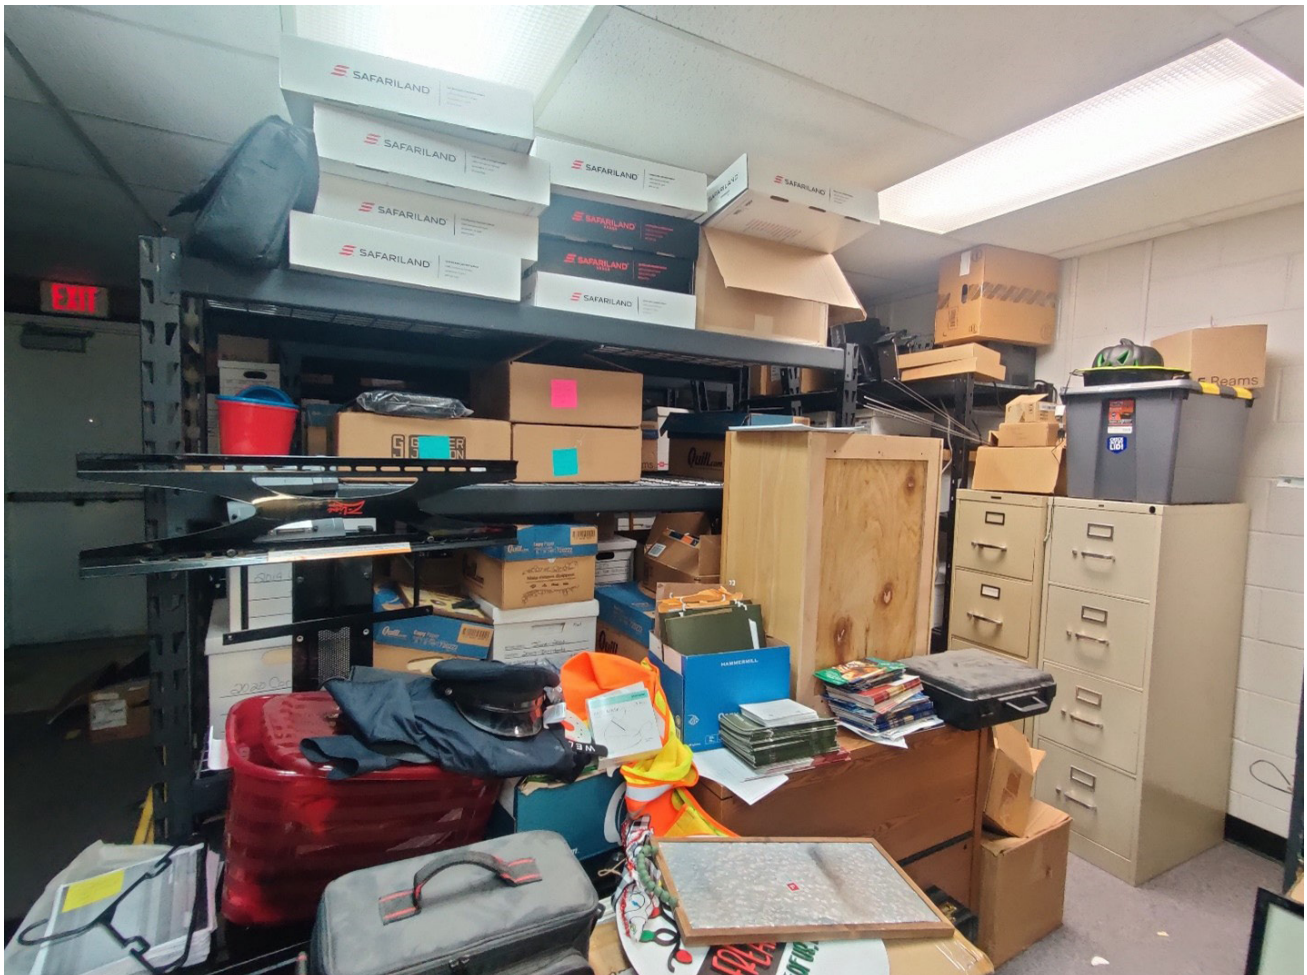
Storage space is lacking throughout the facility. Records room also serves as a large storage room. Stud wall space is being utilized as shelving. The main electrical room is filled with miscellaneous items. Corridors have items piled on the floor potentially impeding the path of egress.
