THE CITY OF CHILLICOTHE, MISSOURI  
POLICE DEPARTMENT HEADQUARTERS

# **FACILITY ASSESSMENT**

613 WALNUT ST. CHILLICOTHE, MO 64601

**DATE COMPLETED:** April 8, 2024

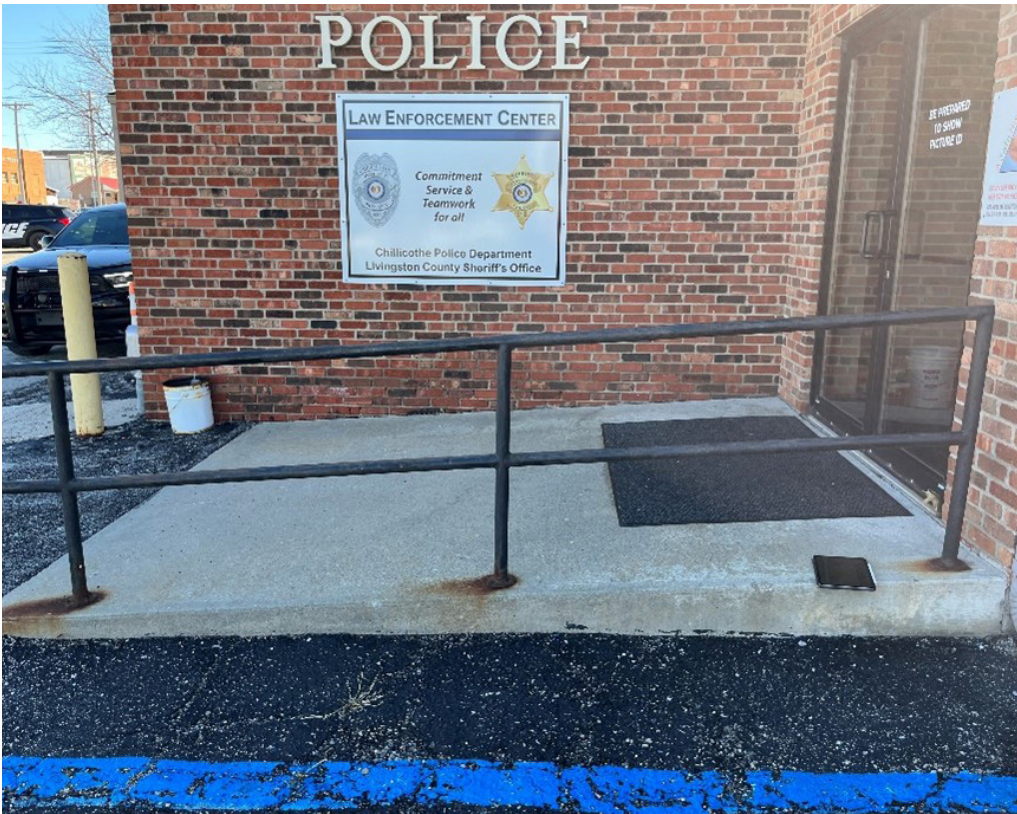
The ramp leading to the North entrance door is under the 5.0% maximum running slope to qualify as a ramp and is therefore in compliance with ADA code. This same requirement applied to the landing to the north of the ramp, which has a slope of 3.30%.

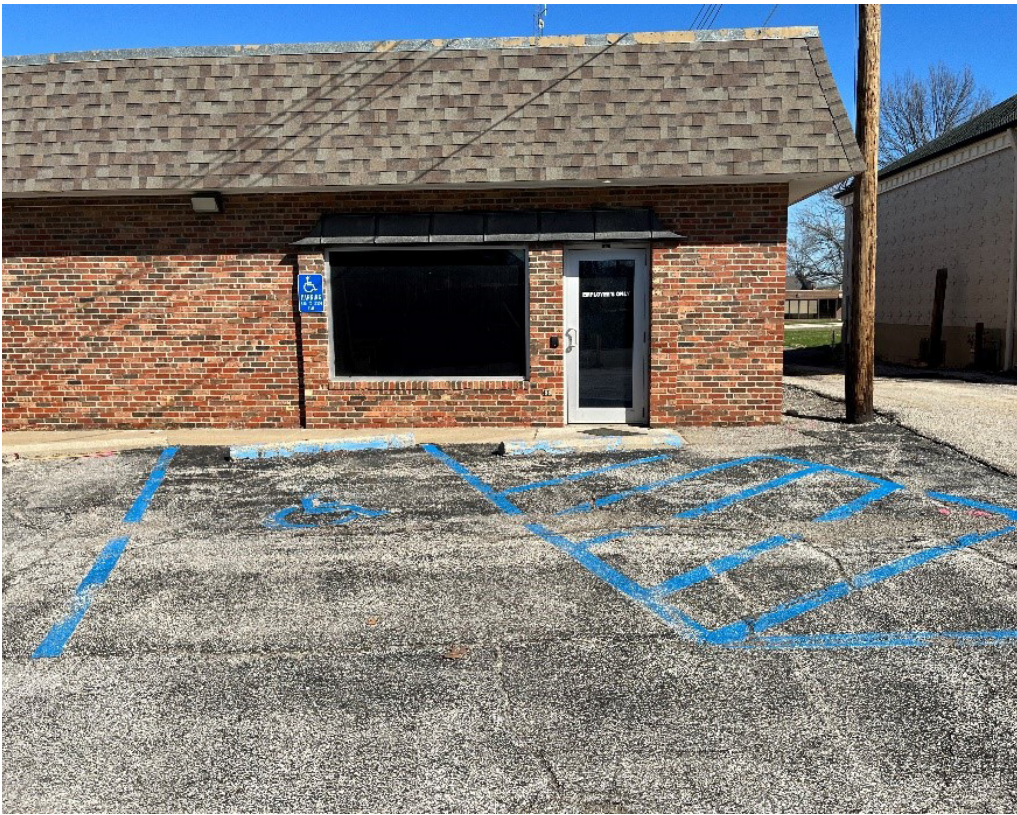
The ADA parking stall to the South of the Police Department is out of compliance with ADA code as its cross slope of 2.20% exceeds the maximum of 2.08% in any one direction.

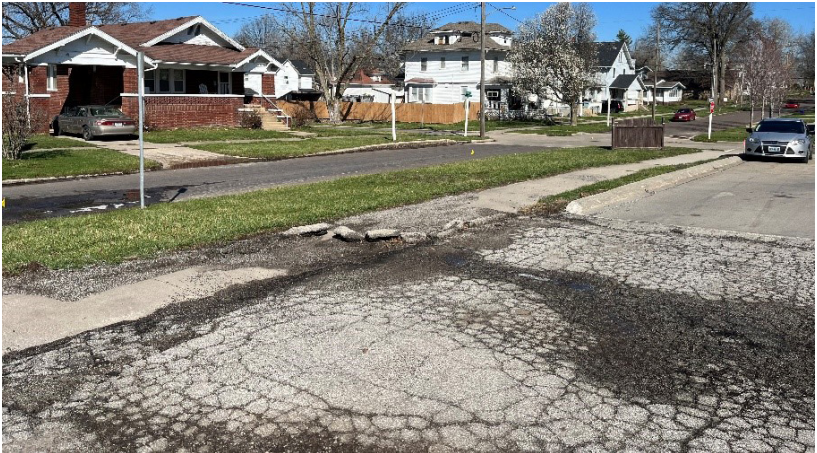
Existing asphalt pavement on all portions of the Police Department parking lot and general site is in poor condition. The parking lot has multiple areas where the surface asphalt has been chipped, rutted, and cracked. Existing curbs have also been cracked and destroyed. Many of these areas have become localized low points where water accumulates as evidenced by sediment deposits. BHC's site visit occurred a few days after a period of rain and these areas were still damp or had evidence of previous standing water.

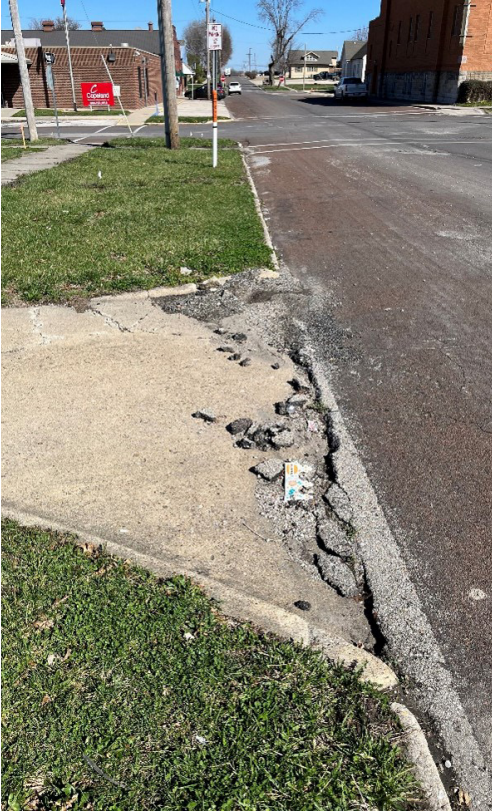
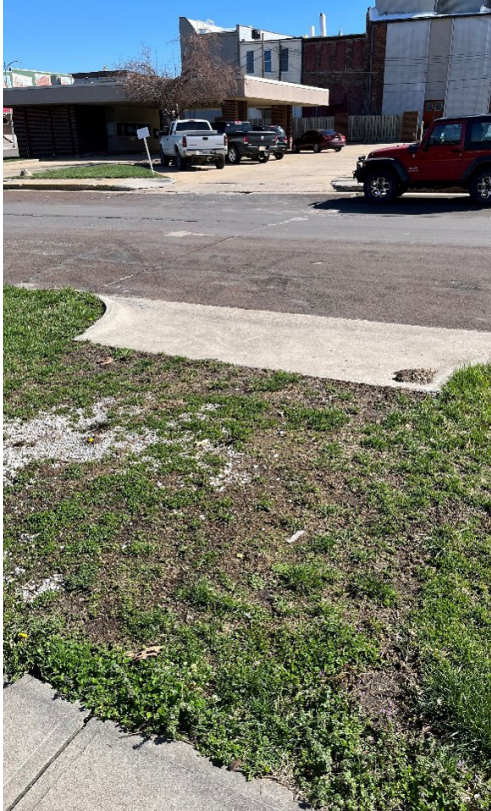
On the East side of the property, there are three partial driveways with curb cuts onto Cherry Street.

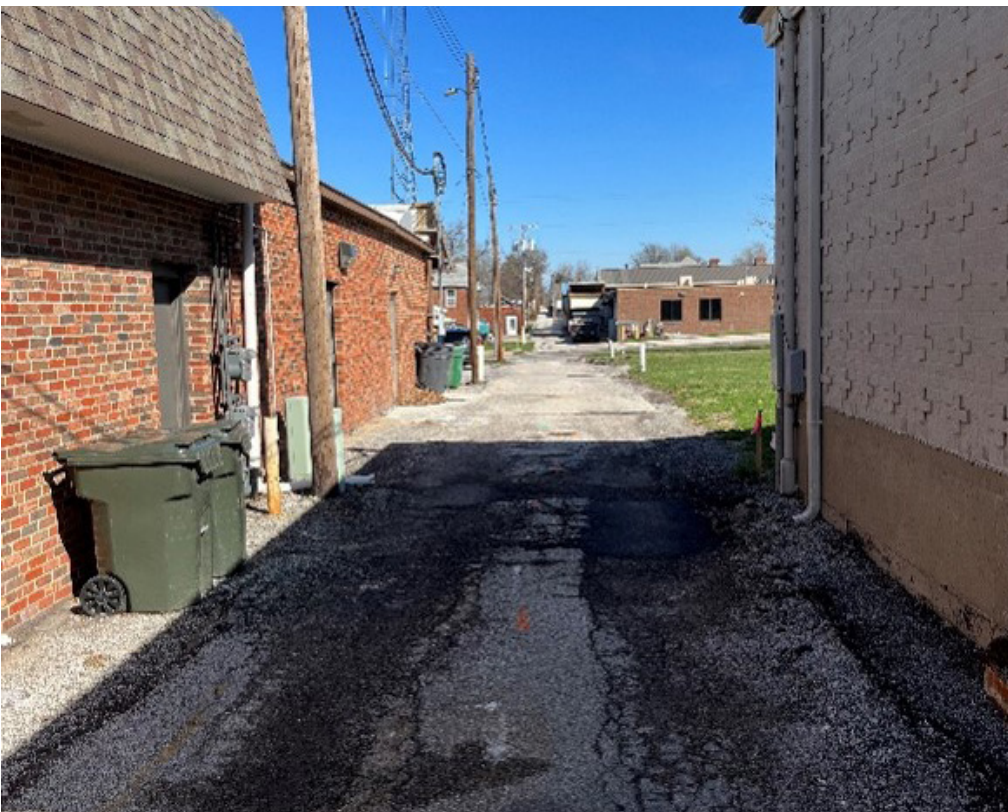
The paved alley that bisects the Police Department site is in poor condition and has multiple areas of partially destroyed asphalt pavement. Roof drains from the Police Department and exiting building to the East discharge into this alley. In some areas, this discharge point is rutted out and appears to be a local low point where water stands.

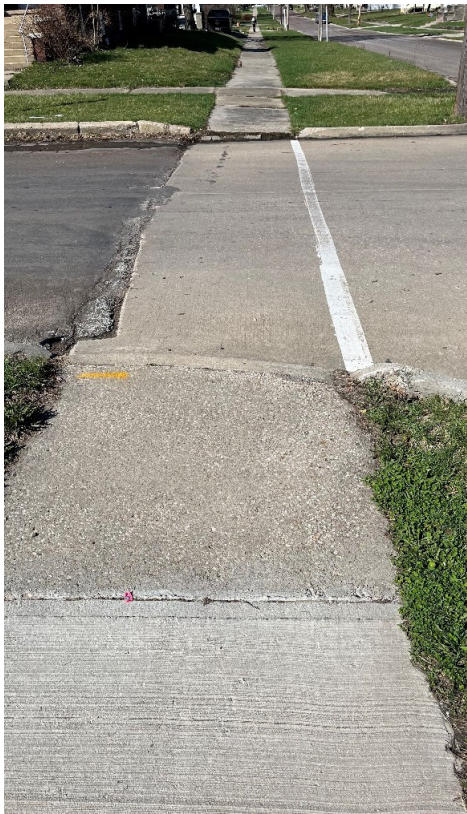
The existing sidewalks surrounding the Police Department property are in a mixed state, varying from poor to acceptable conditions. There is a portion of the sidewalk on the West property line that has destroyed curb blocking the walkway with what appears to be base course covering it. Many of the sidewalk ramps to the public street and crosswalks do not meet ADA standards for a ramp as the sidewalk ends at a full height curb. Many of the sidewalks have areas that appear to have standing water as evidenced by sediment deposits.

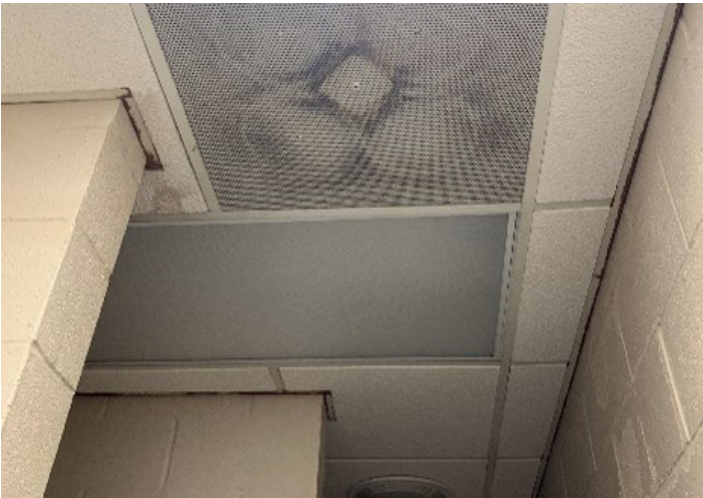
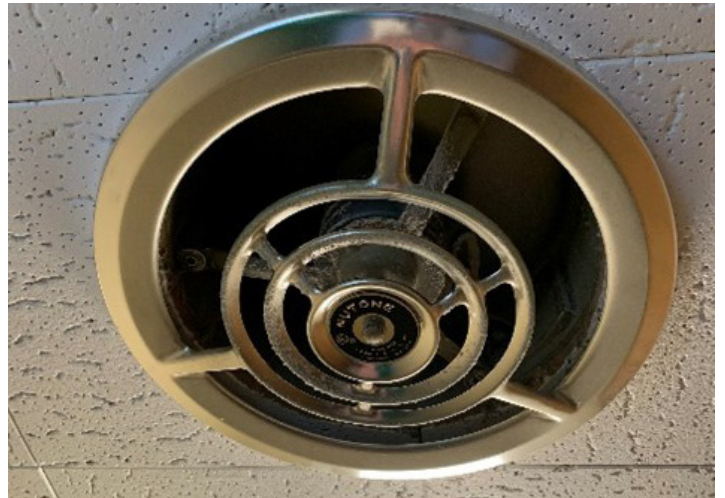
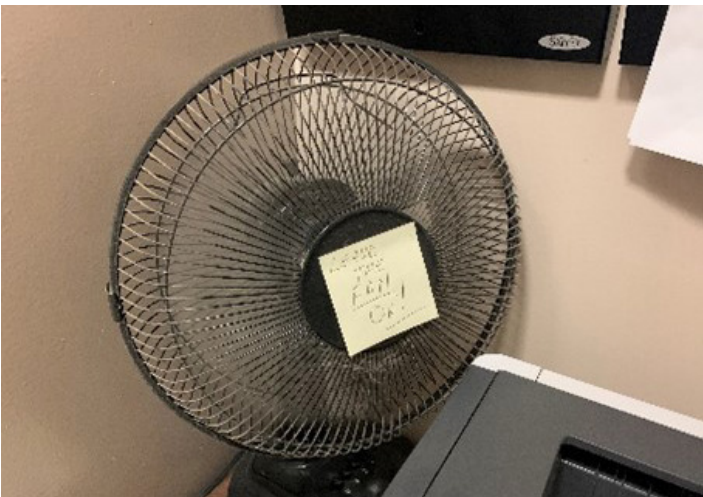
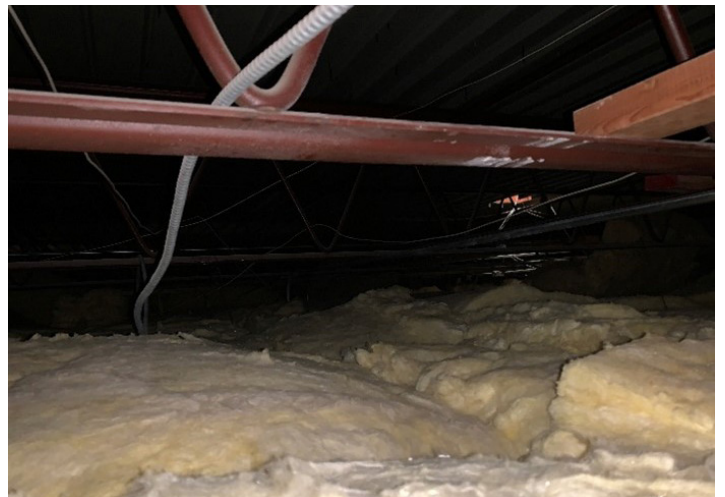
Most ductwork does not have insulation. Transfer grilles create holes in walls reducing sound privacy to zero. The ceiling is insulated with unfaced Batt insulation that lays on top of the ceiling tiles. This insulation is not tight, and allows significant infiltration from ceiling plenum. This ceiling return plenum is uninsulated.

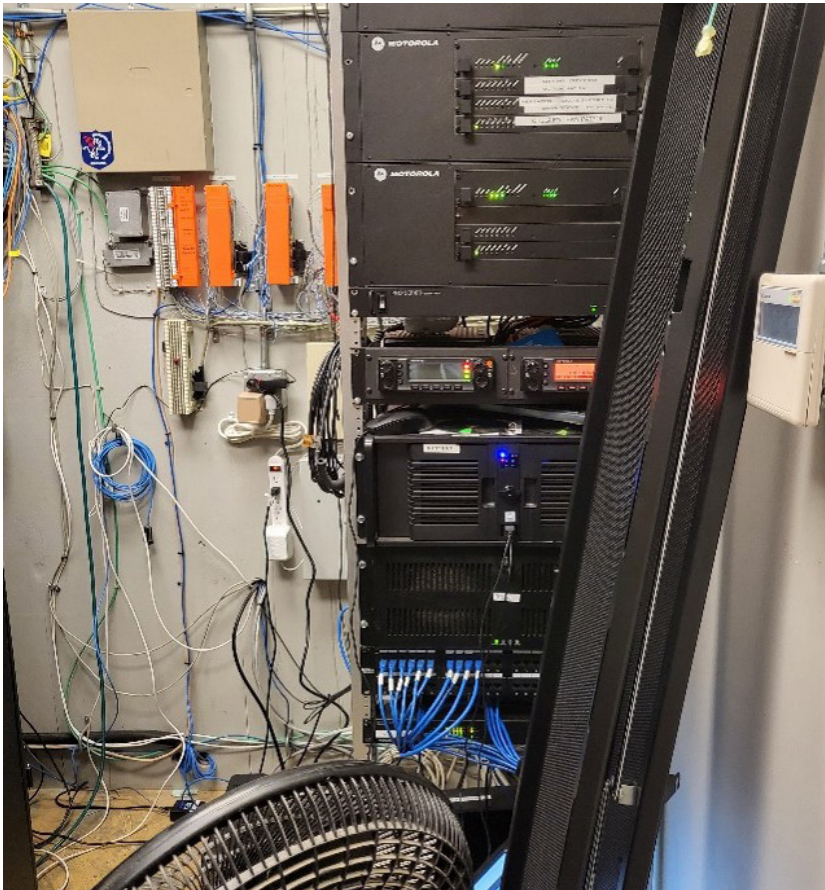
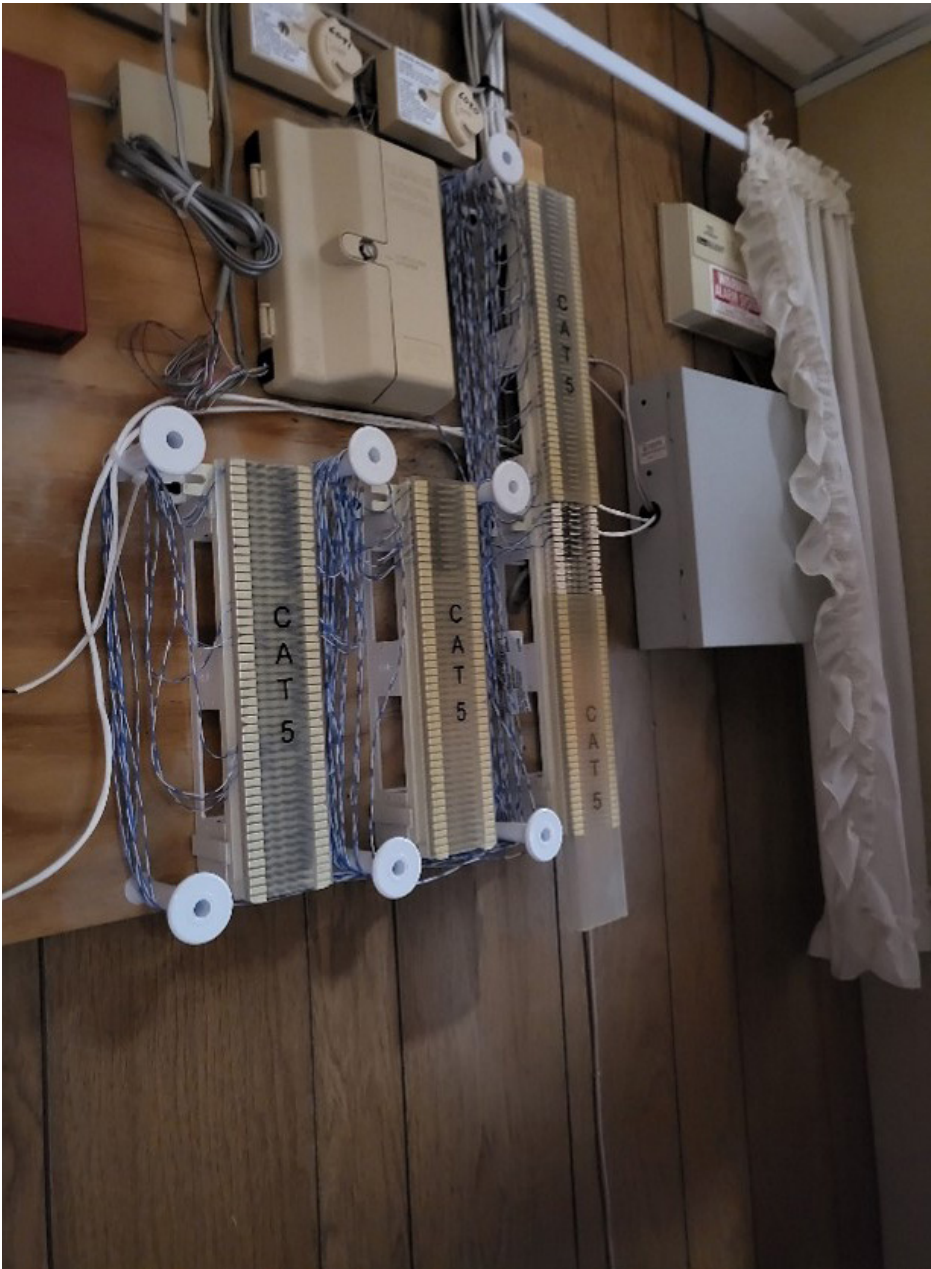
Technology on the police side of the building has been updated and appears to be appropriate for the building use. The technology room has apparent cooling challenges, and the location is not ideal but workable.

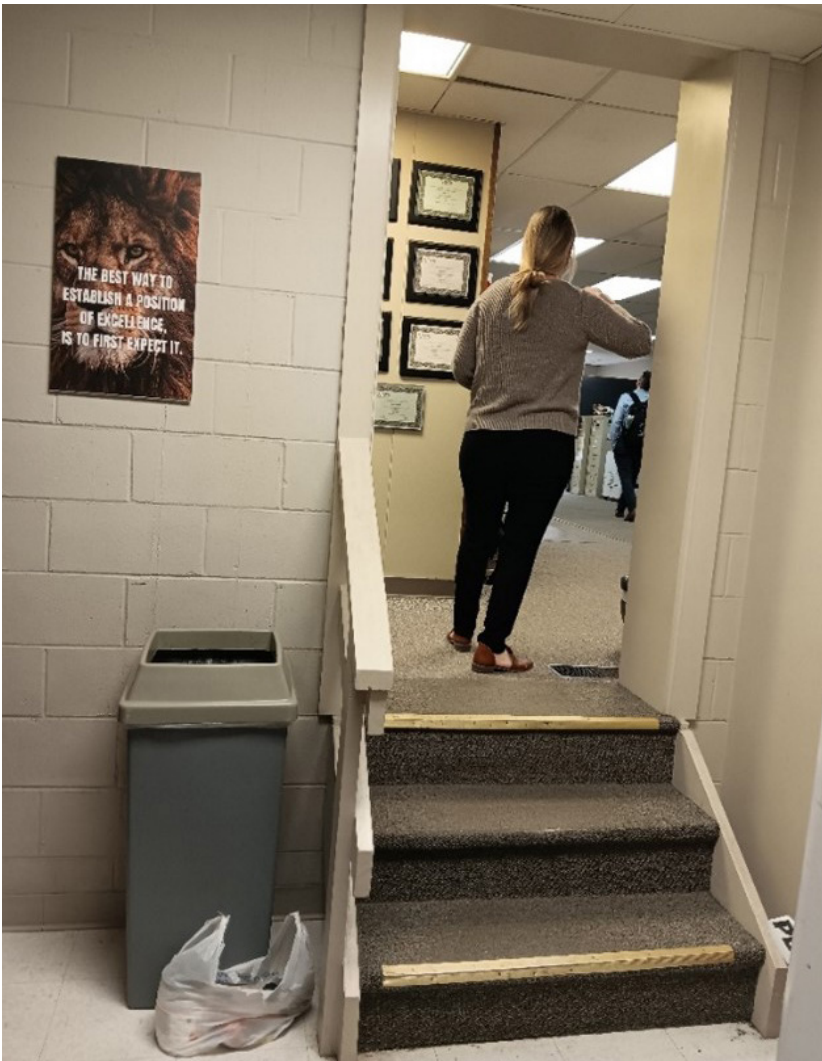
The existing police department is separated on two levels. Only steps have been provided for access. No elevator or ramp has been provided.

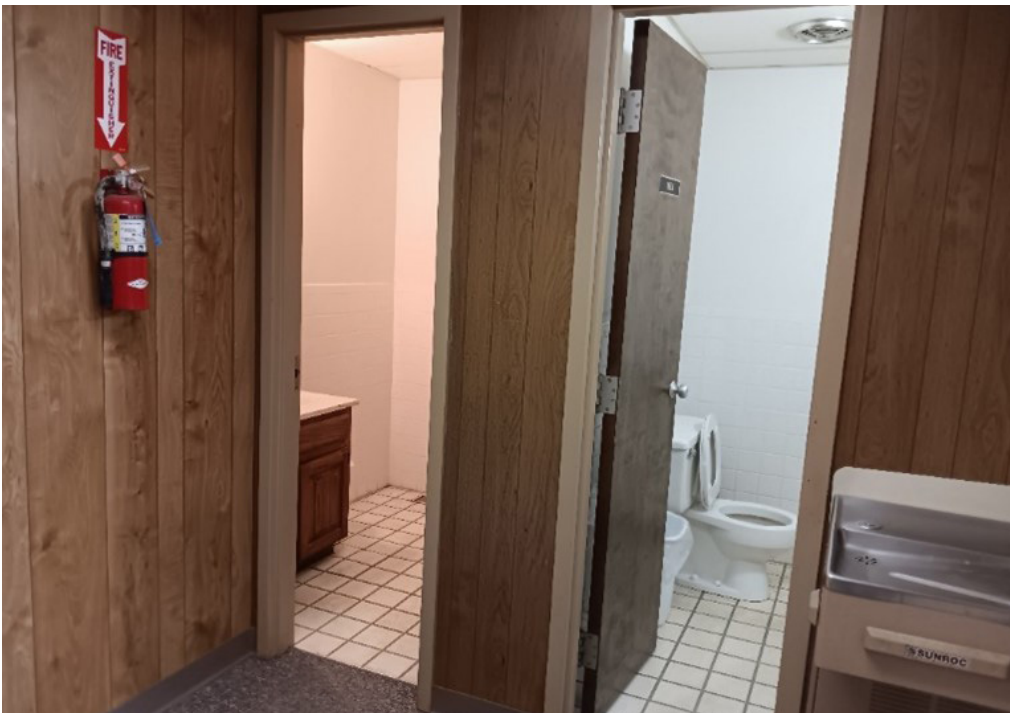
Restrooms entrances need to be 32" clear width for wheelchair access. The doors are currently too narrow. The required push and pull clearance is also not provided.

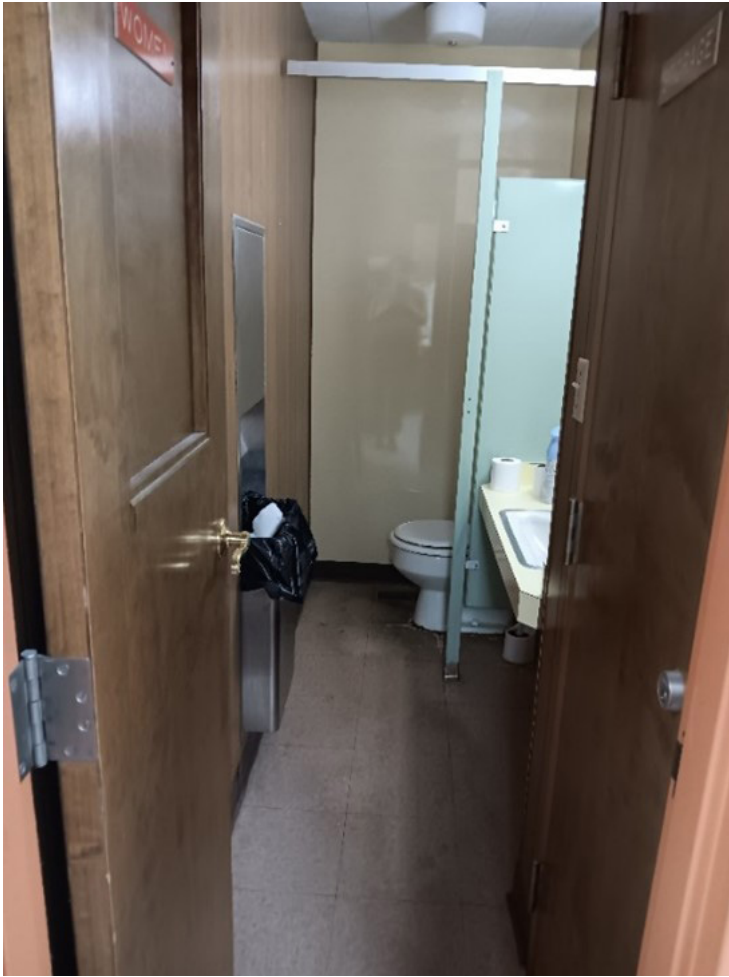
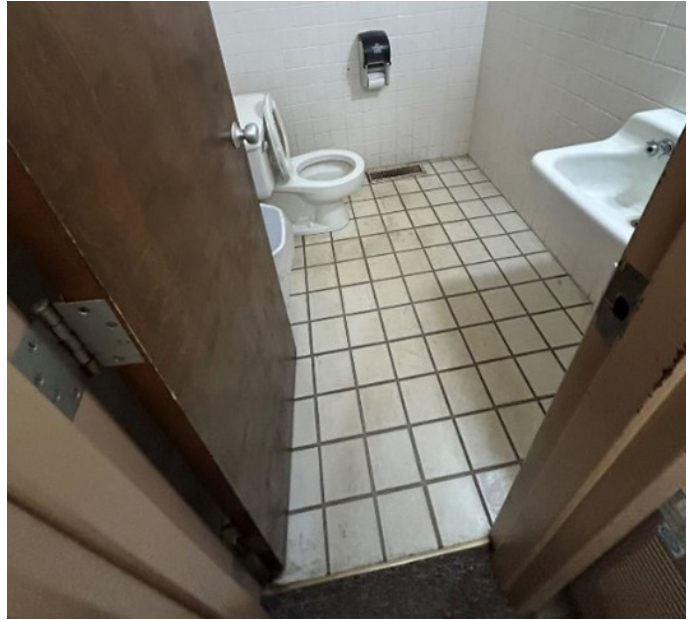
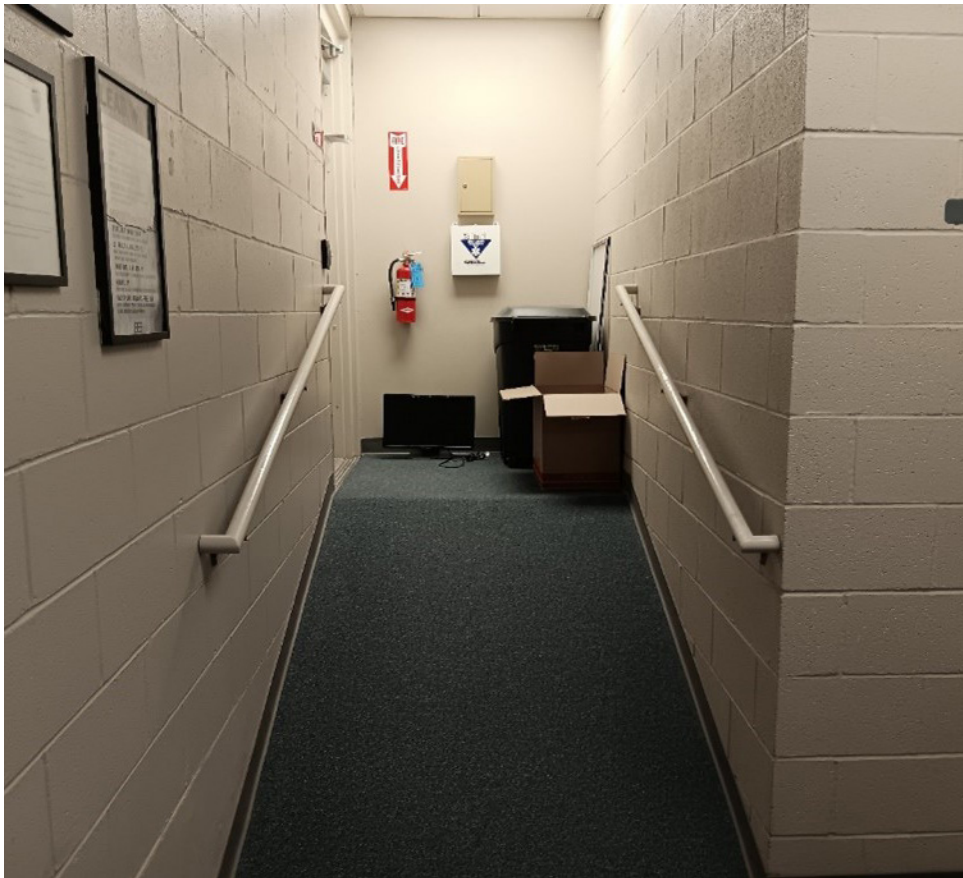
Within the restrooms, the required fixture clearance and turning radius have not been provided. For example a minimum turning area with a diameter of 5'-0" clear is needed.

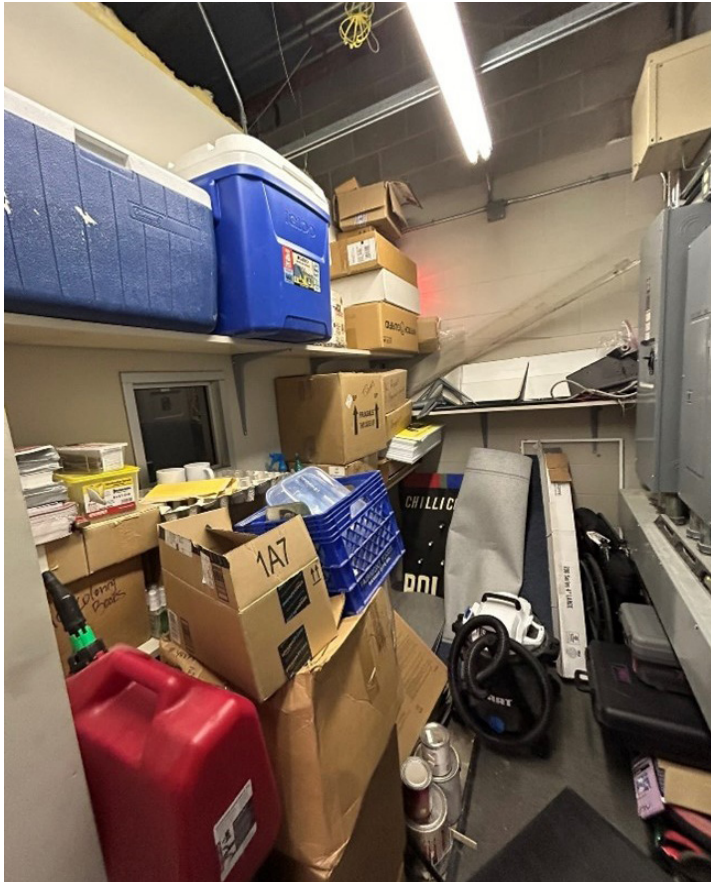
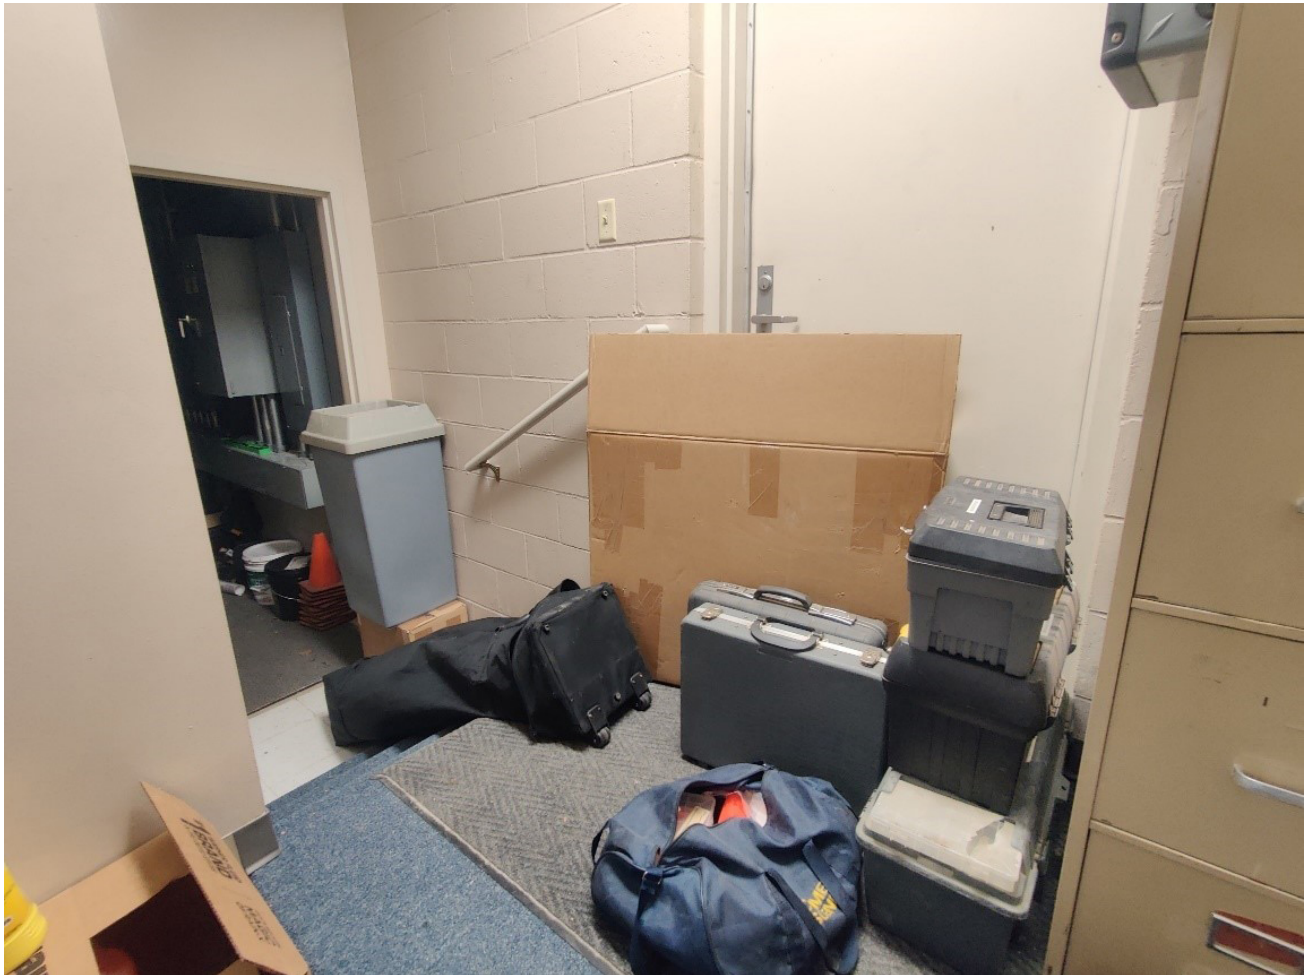
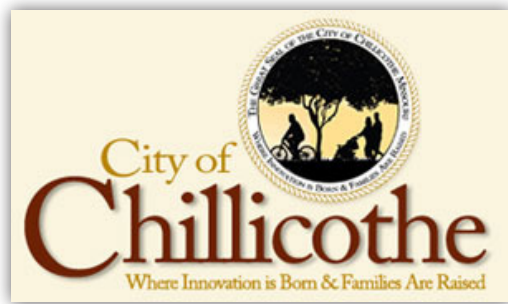
Storage space is lacking throughout the facility. Records room also serves as a large storage room. Stud wall space is being utilized as shelving. The main electrical room is filled with miscellaneous items. Corridors have items piled on the floor potentially impeding the path of egress.
